## The misconceptions of the accident investigation by Japanese Aircraft Accident Investigation Commission (AAIC) and the analysis by ALPA Japan.

Let's point out, the serious misconceptions involved in the Accident Investigation Report, from a technical viewpoint.

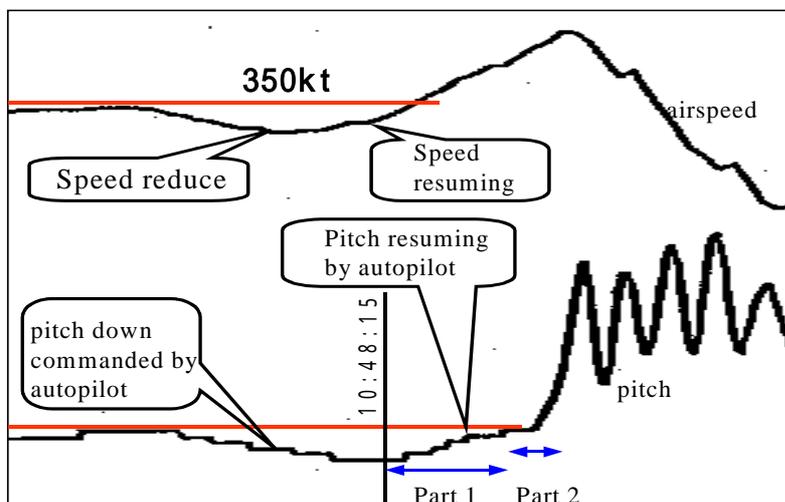
Fig-1

As shown in Fig.1 on the left, the pitch increase starts in the beginning with a slow rate (Part 1), followed by an abrupt one (Part 2).

part 1 and part 2 are caused by different factors. As for part1, at first a pitch decrease was commanded by the autopilot, ahead of the pitch increase command. There was an airspeed deceleration due to a wind change. The autopilot pitched down to accelerate to the commanded speed. As the airspeed returned to its commanded value, the autopilot gradually started to pitch back up.

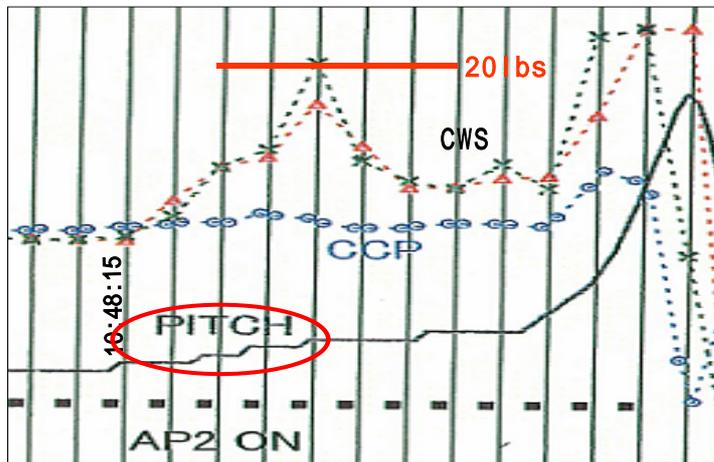
Fig-2

Fig. 2 on the left, which is the AAIC report, is showing only the right half of the graphic above (Fig.1). It only shows the part where the pitch already started upward, thus indicating an intentional pulling of the control column by the captain. In fact it was a pitch up commanded by the autopilot.

Moreover, recorded force, applied to the control column at that time, is lower than 20lbs. According to the McDonnell Douglas technical information, applying a force of less than 20lbs, will not cause the nose-up motion. So, it is obvious that the pulling of the control column, did not cause the nose-up motion.

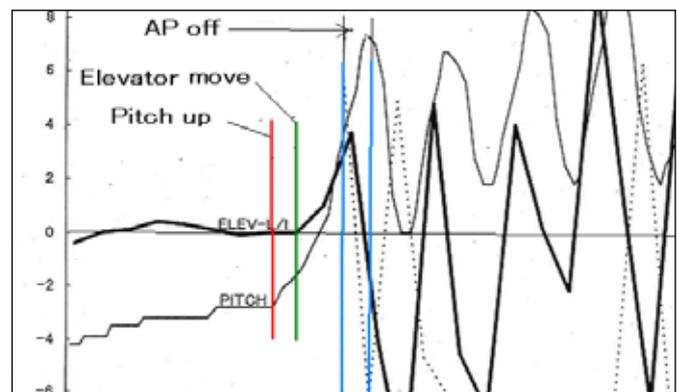
Fig-3

- Let's explain the part 2. On the pitch data record, extracted from the AAIC report, the abrupt nose-up motion began about three seconds before the autopilot was disconnected. Moreover the nose-up motion was started, before the elevator was moving. This indicates that the pilot's operation was not the cause for the nose-up motion.
- Now let's explain the reason for this abrupt nose-up motion.

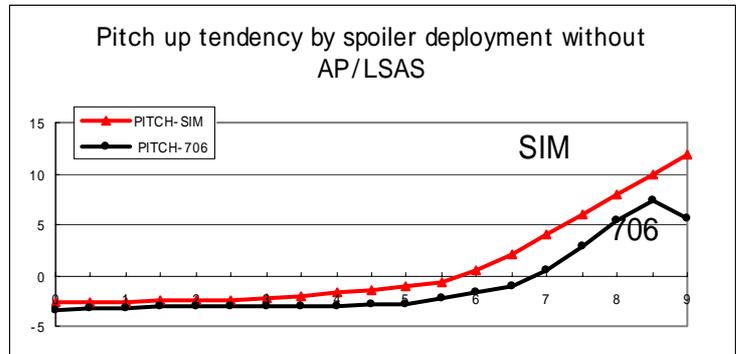
Fig-4

- By deploying the speed brake, a remarkable nose-up tendency will be promoted, which will be normally rectified not to do so, by the autopilot or the LSAS. If the autopilot or the LSAS malfunctioned, how much nose-up motion will occur by deploying the speed brake.
- For this experiment, ALPA Japan used the simulator. As a result of the experiment, almost the same pitch up movement as on the JL706 was confirmed when speed brake was deployed with no autopilot nor LSAS functioning.

Did the autopilot or the LSAS fail to function properly.

- In normal condition, the autopilot or the LSAS will cope with the nose-up motion and stabilize the aircraft, even if the speed brake is deployed. The FCC is always using the atmospheric data in which the aircraft is surrounded, to calculate and determine the commands for aircraft stabilization.
- However, if there is a rapid change of the surrounded atmospheric condition, the calculation cannot be completed timely due to saturation of CPU, thus causing an intermittent malfunction of the computer. This is the same situation as <freezing>, if we make many things do at once with our personal computer. The CPU (central processing unit) of the FCC used in MD-11, is about 20 years older than the CPU in our present personal computers.

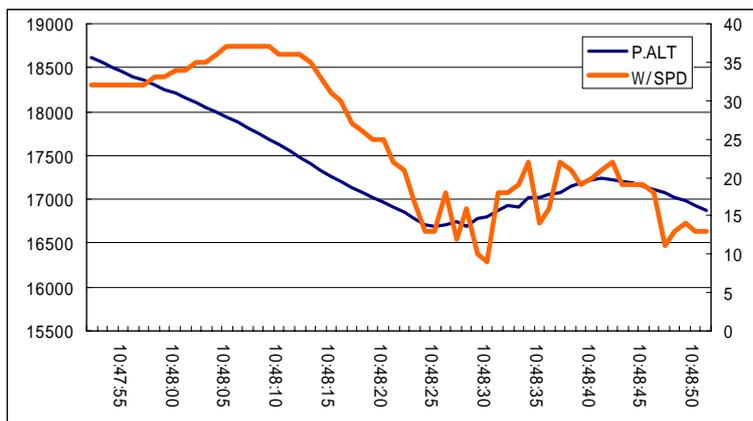
Fig-5

- McDonnell Douglas admits that there was a rapid change of airflow exceeding the limit designed for the autopilot. It is beyond understanding, why the AAIC does not take this into consideration, even if the manufacture company of the airplane, admits the rapid airflow change, exceeding the designed limit.
- How turbulent was the air ,surrounding the aircraft. As one of the examples, Fig.5 indicates the change of the wind speeds at the time of the accident.

The orange line shows that the wind speed has repeated increase and decrease violently. Such changes indicate the existence of a vortex in that specific area, and it also indicates an overloaded situation for the computer calculation.

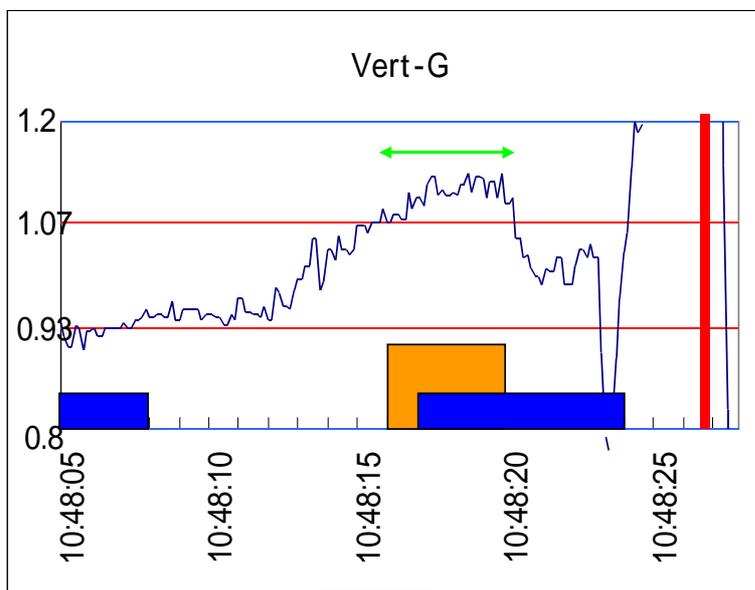
Fig-6

Fig.6 on the left shows the duration that G-force loaded on the aircraft and the deflection of the elevator were out of limit. The G-force, shown with the rugged line, is out of the limitation shown with the two red lines, where indicated by the green arrow. The time zone shown with the blue belt is showing when the horizontal stabilizer was out of the suitable position. The time zone with the brown belt is showing when the autopilot did not react, in spite of the captain's command.

- Taking all these things into consideration, it can be assumed that the FCC, which commands the autopilot and LSAS, was overloaded due to the turbulent airflow surrounding the airplane, and stopped functioning temporarily. Subsequently, an abrupt nose-up motion began by deploying the speed brake at the same time. About the continuing pitch oscillation will be explained later.

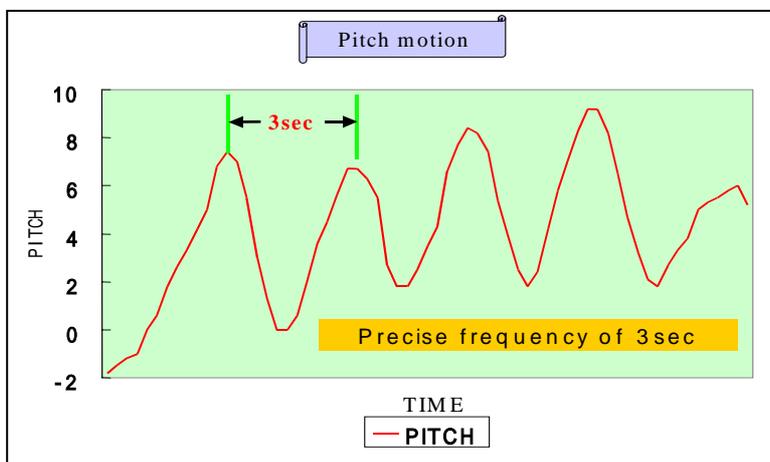
Fig-7

- As it is shown in Fig.7, the repeated up-and-down motion at the time of the accident has a short cycle of about 3 seconds. Moreover, it has a wide up-and-down amplitude of 8deg (a cockpit up-and-down motion of 5-7m), and was repeated with a **very accurate frequency** for 5 times.

- To create an up-and-down motion artificially by pushing and pulling the control column, was experimented using the simulator. However, it was unable to reproduce such repeating pitching motion. As explained previously, the PRD, which was installed to stabilize the pitching motion, stopped the pitching motion immediately.

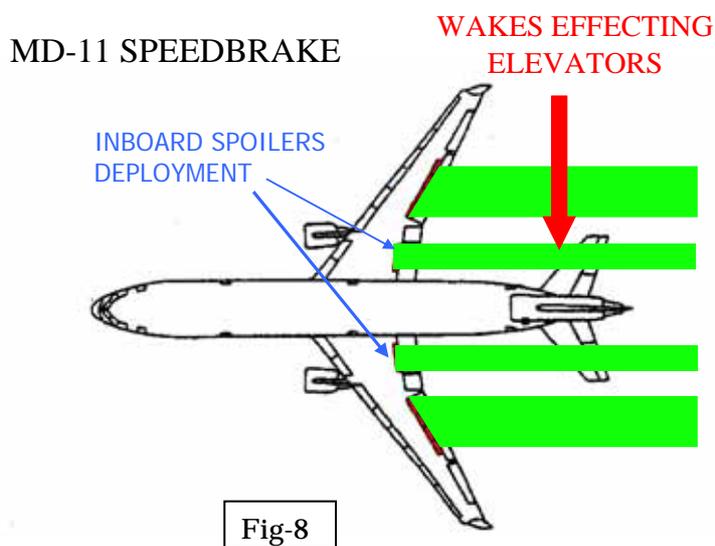
- There are several speed brake panels installed on the main wing (Fig8). Unlike other types of aircraft, all the speed brakes panels of the MD11 type aircraft, are fully deployed including the inner brakes (most close to the fuselage) during flight.

- Wakes from these inboard speed brakes, specific to the MD11, is usually designed not to affect the flight. However, as for the JL706 affected by the vertical vortex in the inversion layer, there is possibility that the wake from the spoilers did adversely affect the horizontal tail.

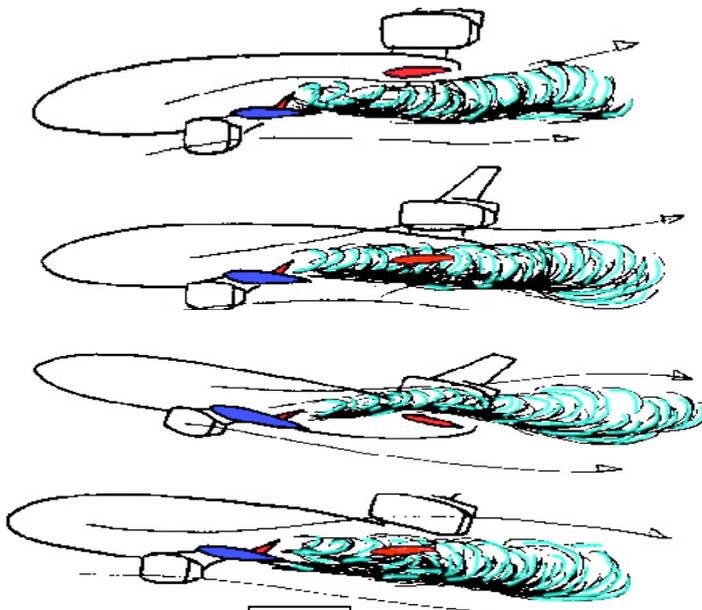
Fig-9

3 Disturbance of the air current passing through the speed brakes affected the horizontal tail and significantly reduced the efficiency of the elevators. Consequently, the elevators were unable to inhibit the nose-up tendency resulting from the use of the speed brake, thus leading to a sharp nose-up motion. At the same time, the BIT function detected a fault in the FCC and disconnected the autopilot.

4 When the elevators and the horizontal stabilizer are no longer affected by the wake that was caused by the use of the speed brakes, as a result of a relatively sharp nose-up motion, the elevators quickly recover and the nose-down motion begins...

5 However, when the nose is lowered, the elevators are affected by the wake again, and the nose-up motion begins again, thus being unable to

6 After closing the speed brakes, the wake disappeared and the aircraft regained stability.
