# Ninoy Aquino International Airport (MNL), the Philippines

IATA Operations Notice Number: ON 003/2021

Title: Ninoy Aquino International Airport (MNL), the Philippines

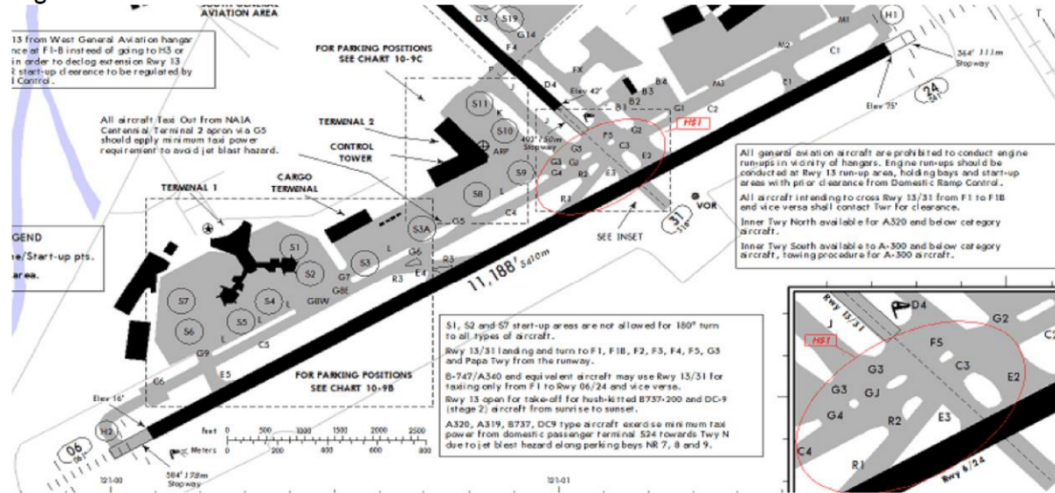
Figure 1:

1. Lack of current aeronautical charts that accurately depict the airfield layout, dimensions and markings
2. Ongoing events of unauthorized illumination of aircraft by laser when operating at MNL airport
3. The intersection of RWY 31 /13 and RWY 06/ 24. This intersection is a known 'hot-spot' area as shown in Figure 1 below. Flight crews have described this hotspot area as:
  - Poorly lit
  - Markings and signage that are non-standard and poorly maintained
  - Confusing due to the complex configuration of taxiways

- Alert flight crews of the existing hazards and potential for runway incursion in the 'Hot-Spot' area and apply appropriate operating procedures to mitigate the associated risks
