Another Possible Cause of AA587 A300-605R Accident

July 18, 2005

This brief report is prepared to explain the possibility that the inertial forces on the control linkages moved control surfaces, or at least influenced very much on pilot's control feel forces on AA587 accident.

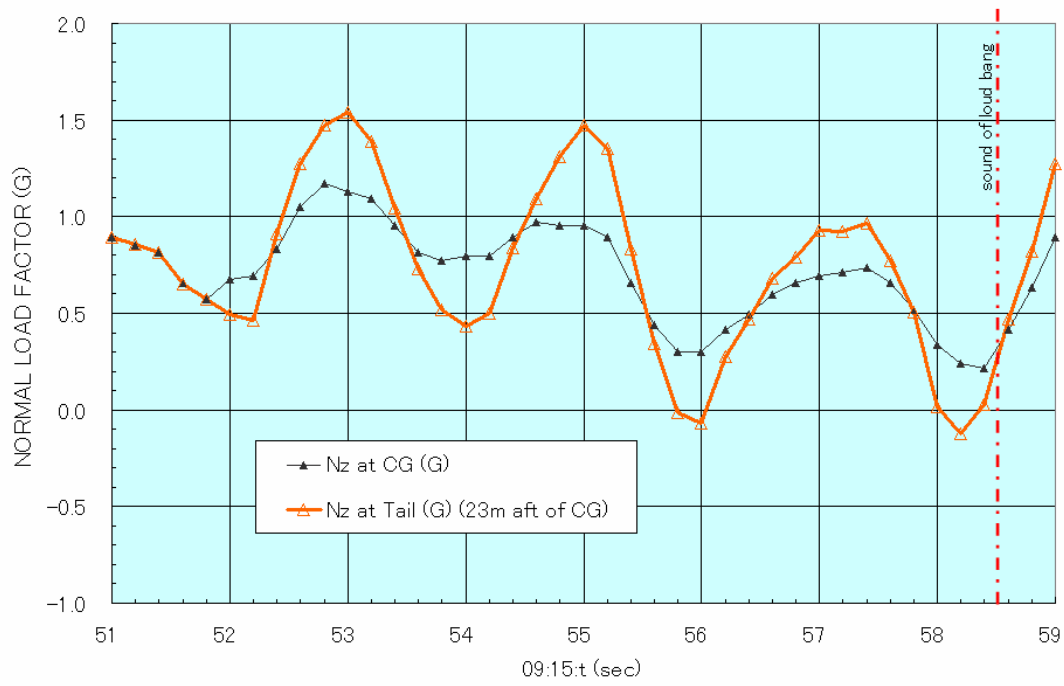
Fig. 1 Normal Load Factor at Tail

Figure 1 is the normal load factor at tail, and Figure 2 is the lateral load factor at tail. Tail position is assumed 23 meter aft of CG. Flight data and calculation method are based on Ref. [1]. Both normal and lateral load factors at tail are fluctuating very much.

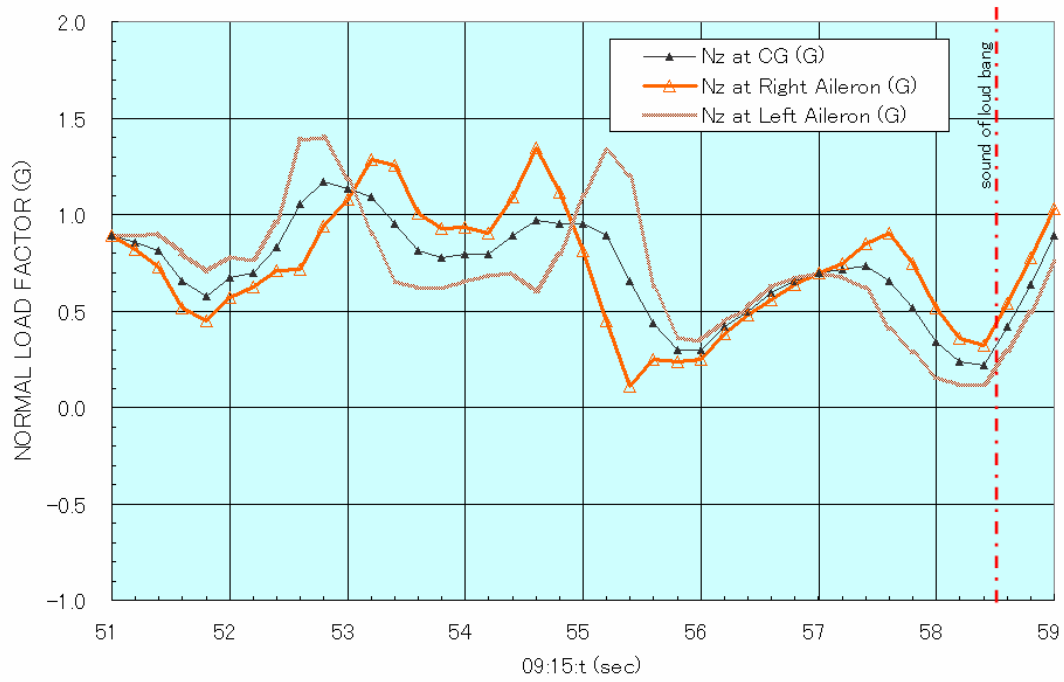
Fig. 3 Normal Load Factor at Aileron

Figures 3 thru 5 are the three axis load factors at aileron. Aileron position is assumed 7 meter right or left of CG. Reciprocating longitudinal load factors are noteworthy.

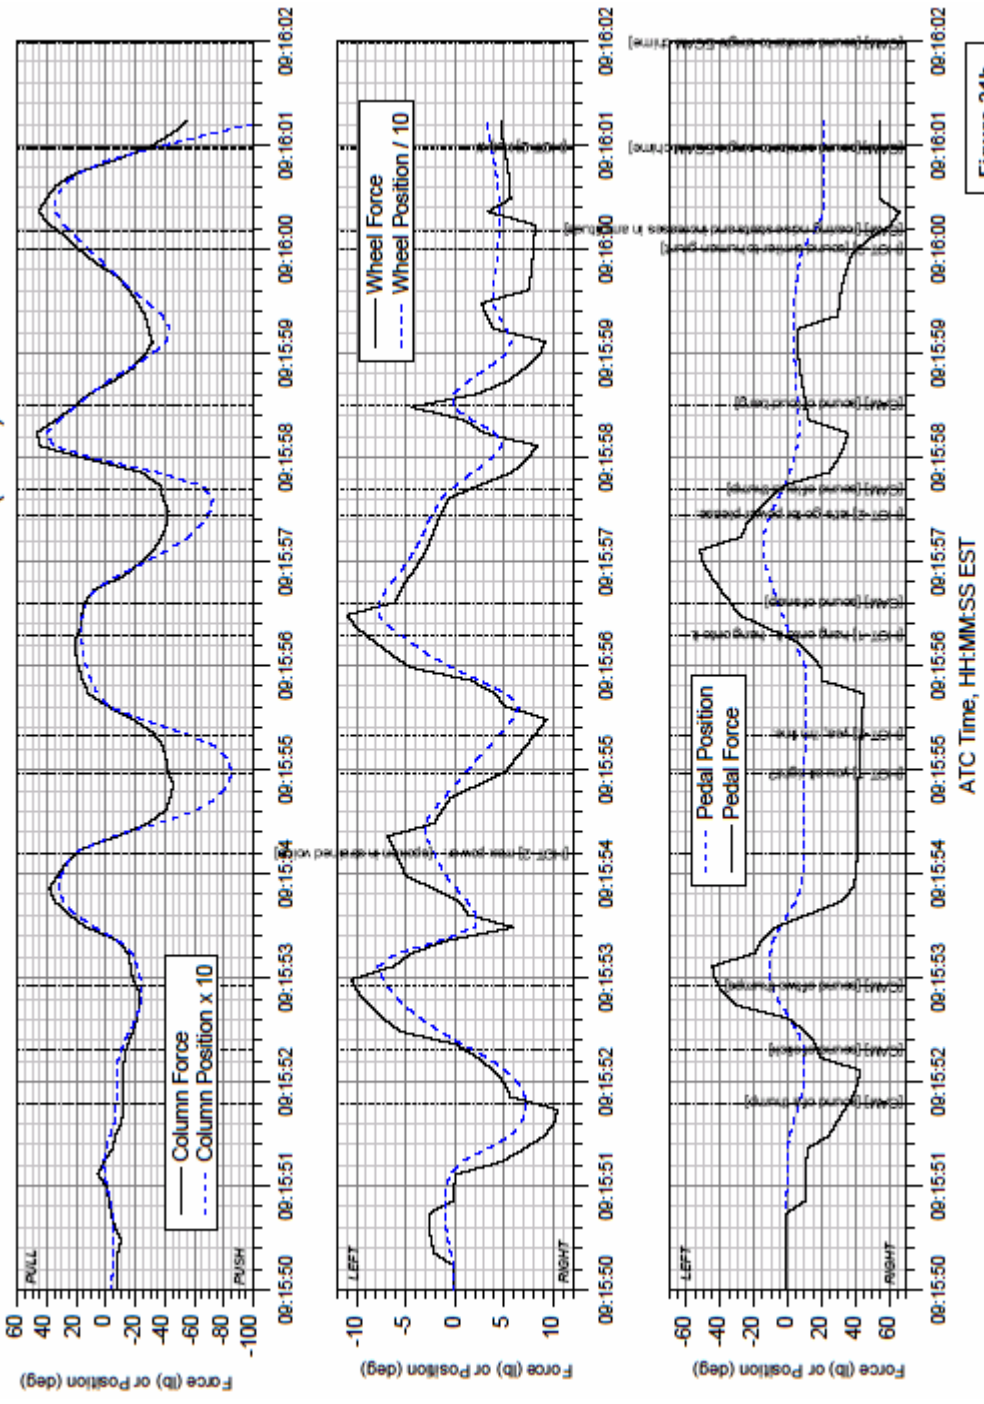
Fig.6 Control Positions and Calculated Forces (Ref. [1])

Figure 6 from Ref. [1] shows the control positions and calculated control forces. Comparing the local load factors with Figure 6, one could find out many correlations.

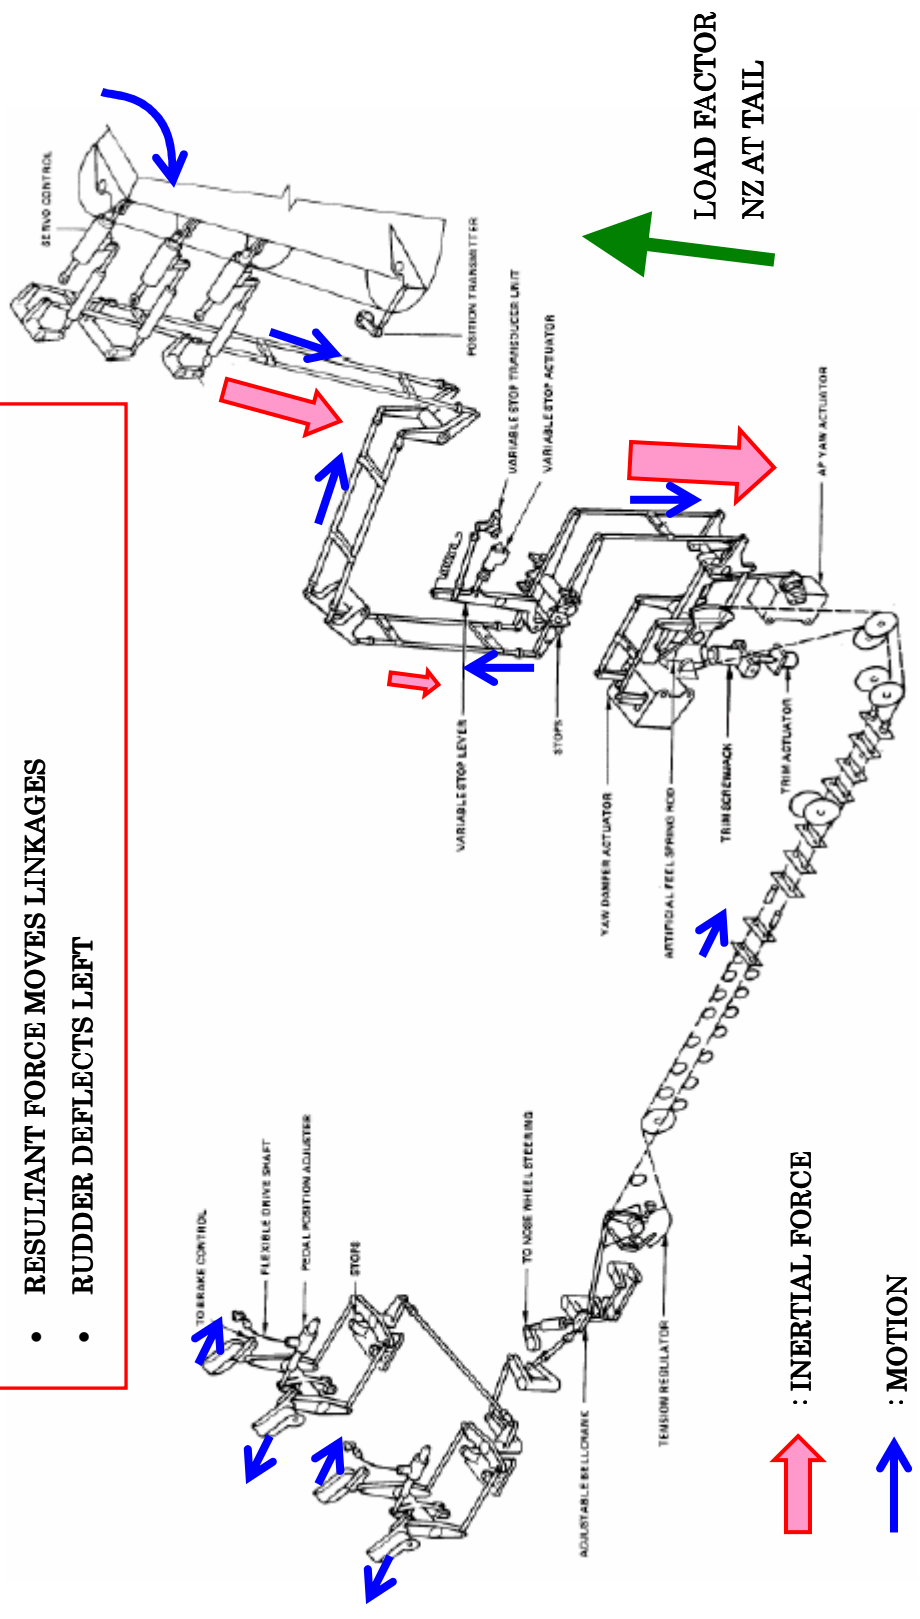
Fig.7 Rudder Control System (Ref. [2])

- WHEN NORMAL LOAD FACTOR AT TAIL INCREASES UPWARD
- INERTIAL FORCES ACT ON LINKAGES DOWNWARD
- RESULTANT FORCE MOVES LINKAGES
- RUDDER DEFLECTS LEFT

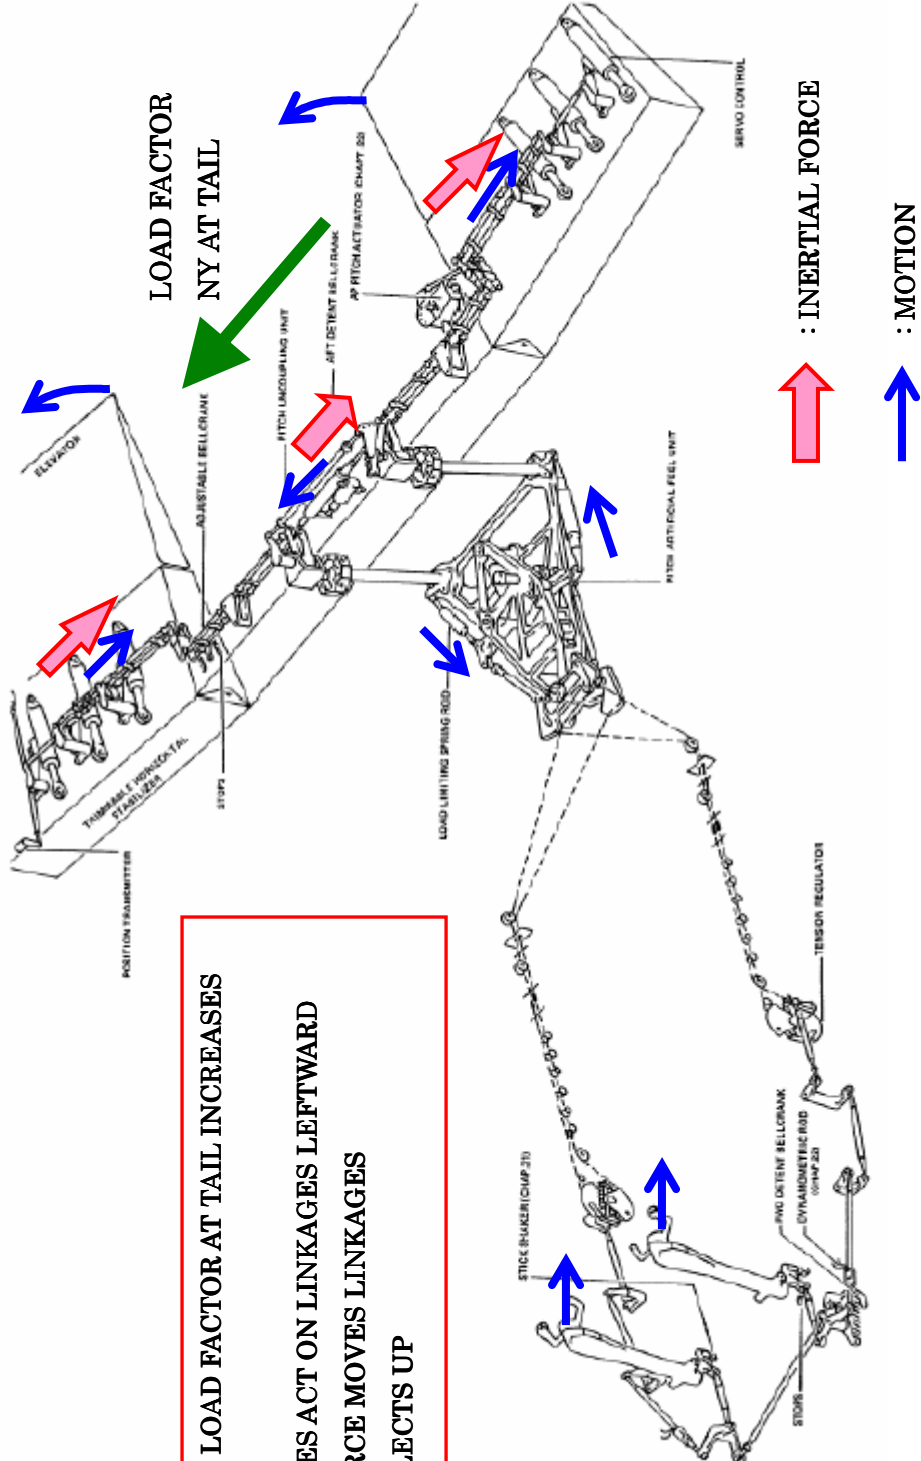
Fig.8 Elevator Control System (Ref. [2])

- WHEN LATERAL LOAD FACTOR AT TAIL INCREASES RIGHTWARD
- INERTIAL FORCES ACT ON LINKAGES LEFTWARD
- RESULTANT FORCE MOVES LINKAGES
- ELEVATOR DEFLECTS UP

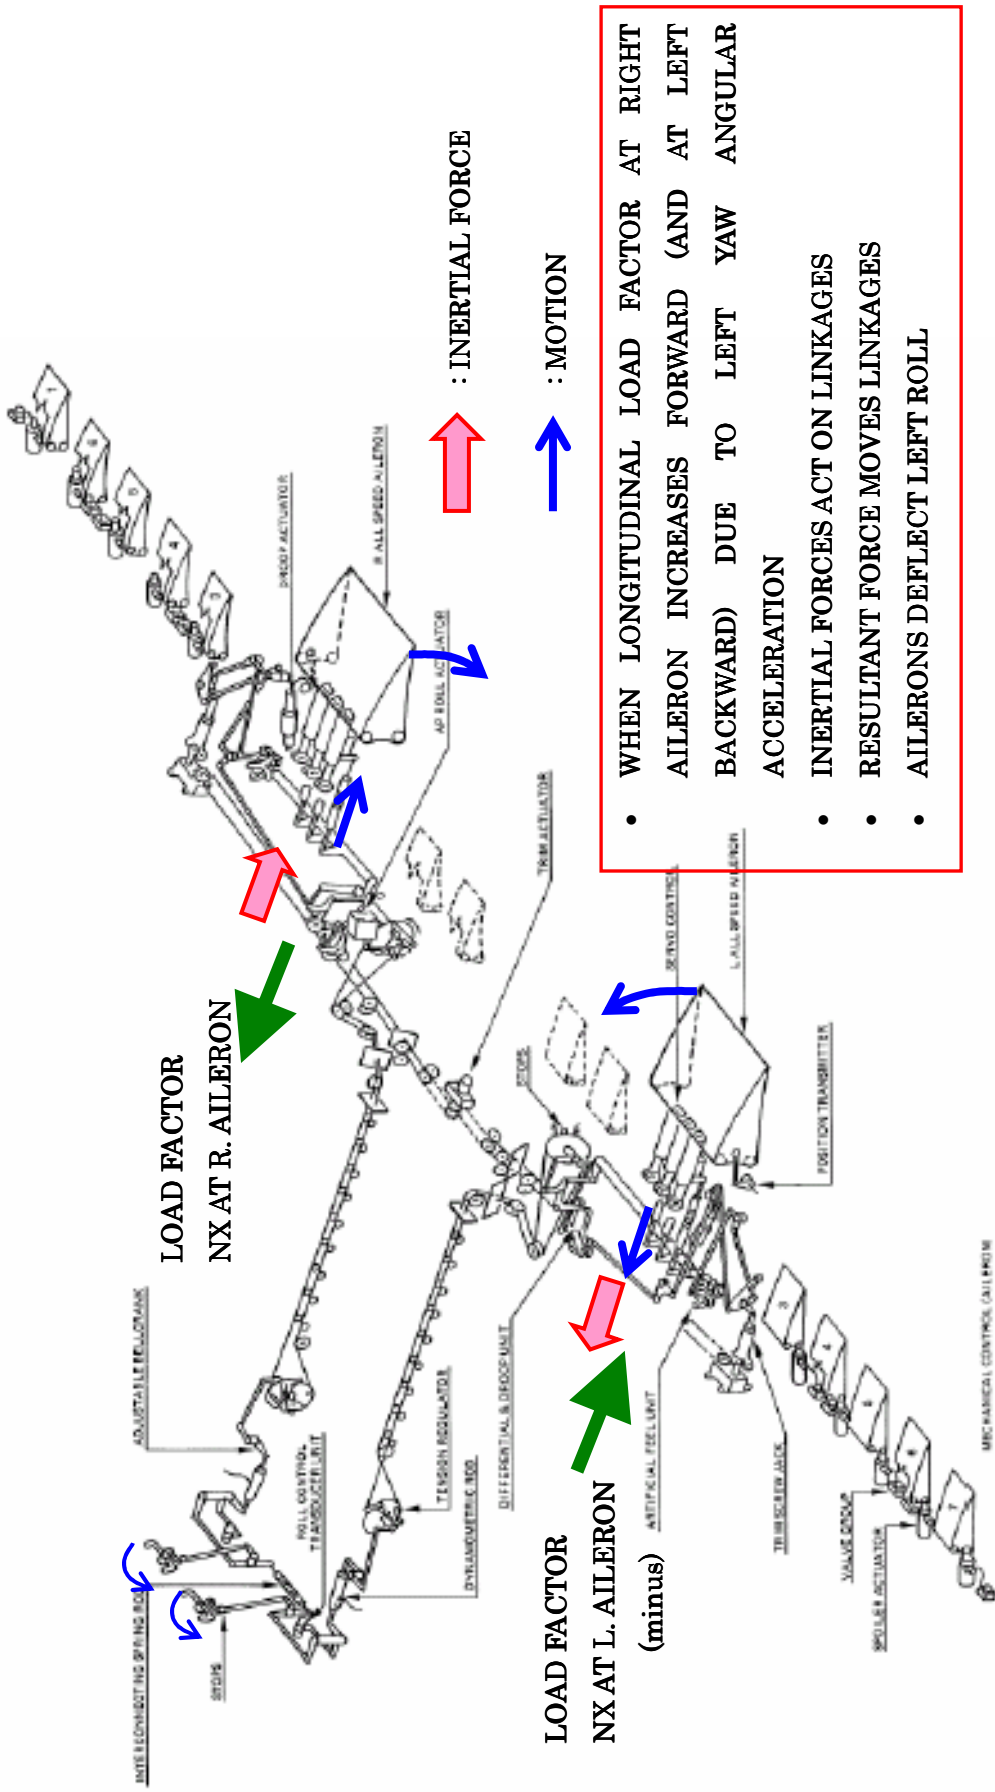
Fig.9 Roll Control System (Ref. [2])

- WHEN LONGITUDINAL LOAD FACTOR AT RIGHT AILERON INCREASES FORWARD (AND AT LEFT BACKWARD) DUE TO LEFT YAW ANGULAR ACCELERATION
- INERTIAL FORCES ACT ON LINKAGES
- RESULTANT FORCE MOVES LINKAGES
- AILERONS DEFLECT LEFT ROLL

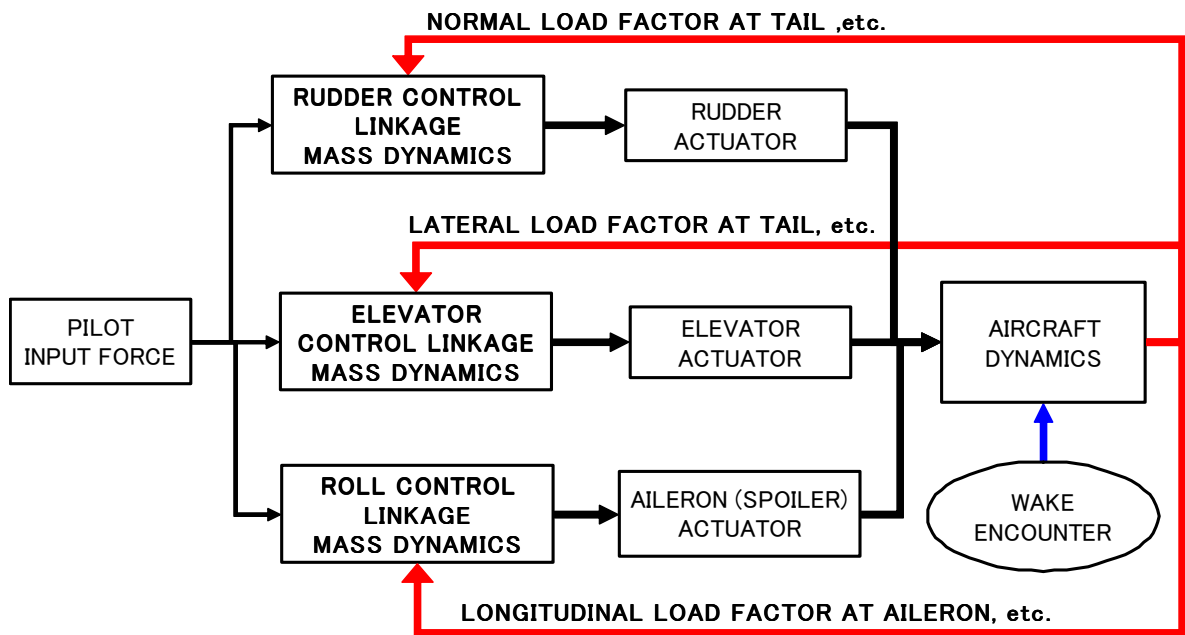
Fig.10 Block Diagram of Aircraft Dynamics with Linkage Mass Dynamics

The aircraft dynamics and control linkage dynamics are intricately related. They are illustrated in figures 10 and 11. It is suggested that the pitch-yaw-roll near self-induced oscillation kicked off by wake encounter was mostly what happened on AA587 accident.
