# Japan Airlines 706 Accident Investigation Report

Japan Airlines McDonnell Douglas MD-11 JA8580

Over Shima Peninsula, Mie Prefecture, Japan

ALPA Japan Technical Support Team

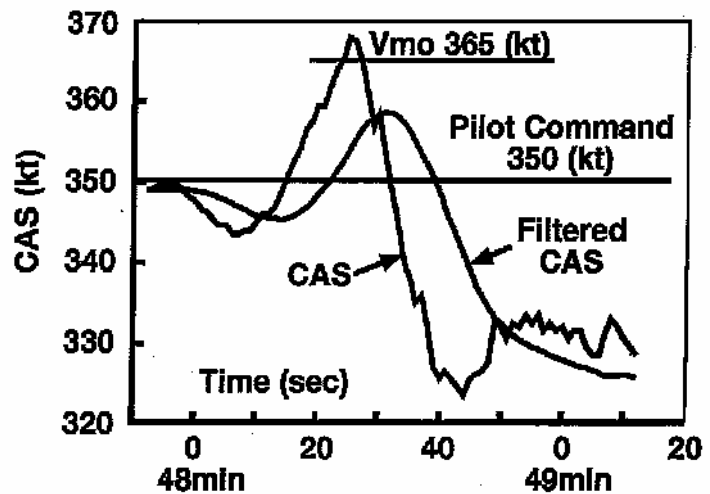
**CAS & A/P Filtered CAS**

The MD-11 flight crew of Japan Airlines were never informed of the fact that the FCC uses a filtered airspeed signal, nor is there any indicator in the cockpit that displays this filtered airspeed or the dissociation of between the two signals.

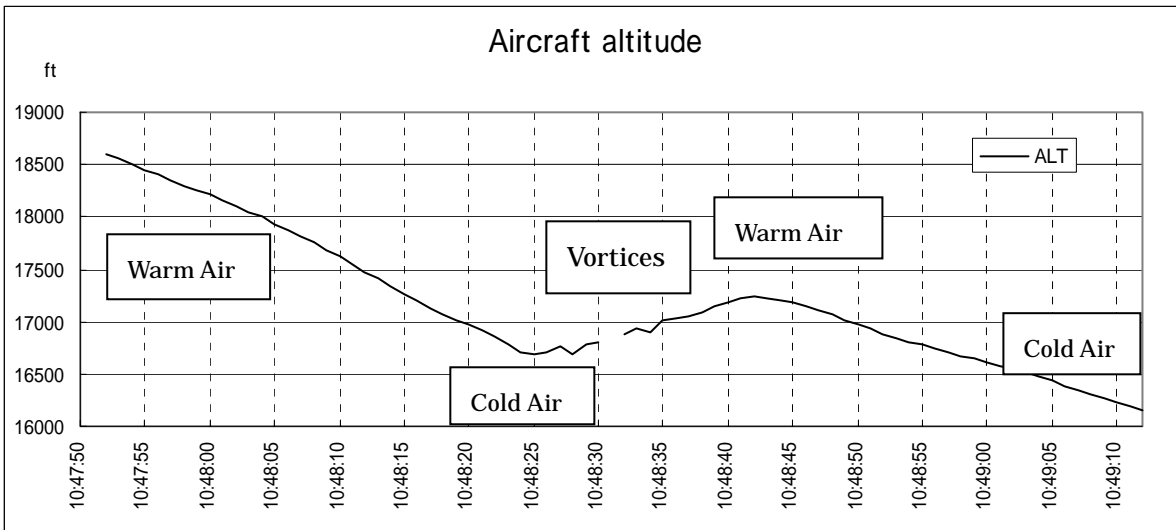
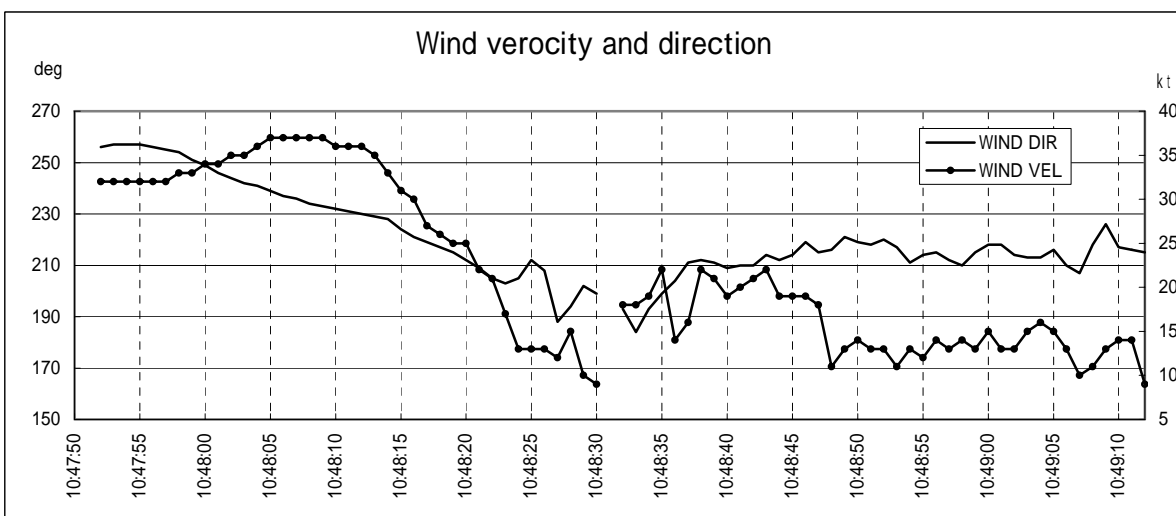
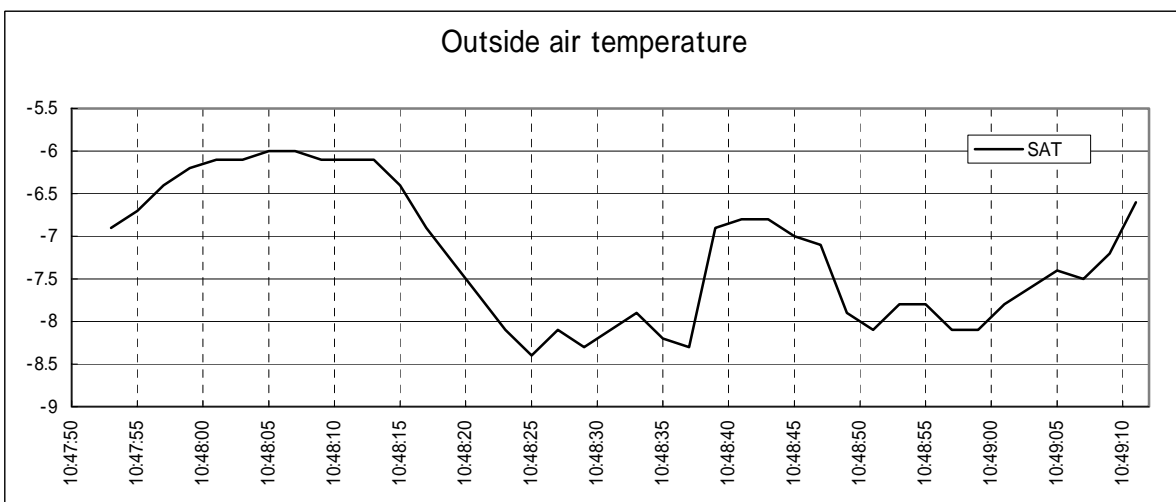
through 17,111 feet, decreased 0.8°C in one second. This is an indication that warm air was flowing into the area above approximately 17,100 feet.

The OAT decreased after which the rate of change dropped. At 10:48:59, the aircraft entered a layer of constant temperature and then for the remainder of the descent, a condition very close to the standard lapse rate was recorded.

This condition of the atmosphere on the route of descent was caused by the low pressure system that was approaching the Kii Peninsula, causing the warm air that it brought with it from the Kyushu/Chugoku area to rise above the cold air that existed over the Kinki/Chubu area. This indicates that there was an area of atmospheric discontinuity brought about by the very prominent temperature difference of the converging air masses along the air route above the Shima Peninsula between the altitudes of 18,200 to 16,600 feet.

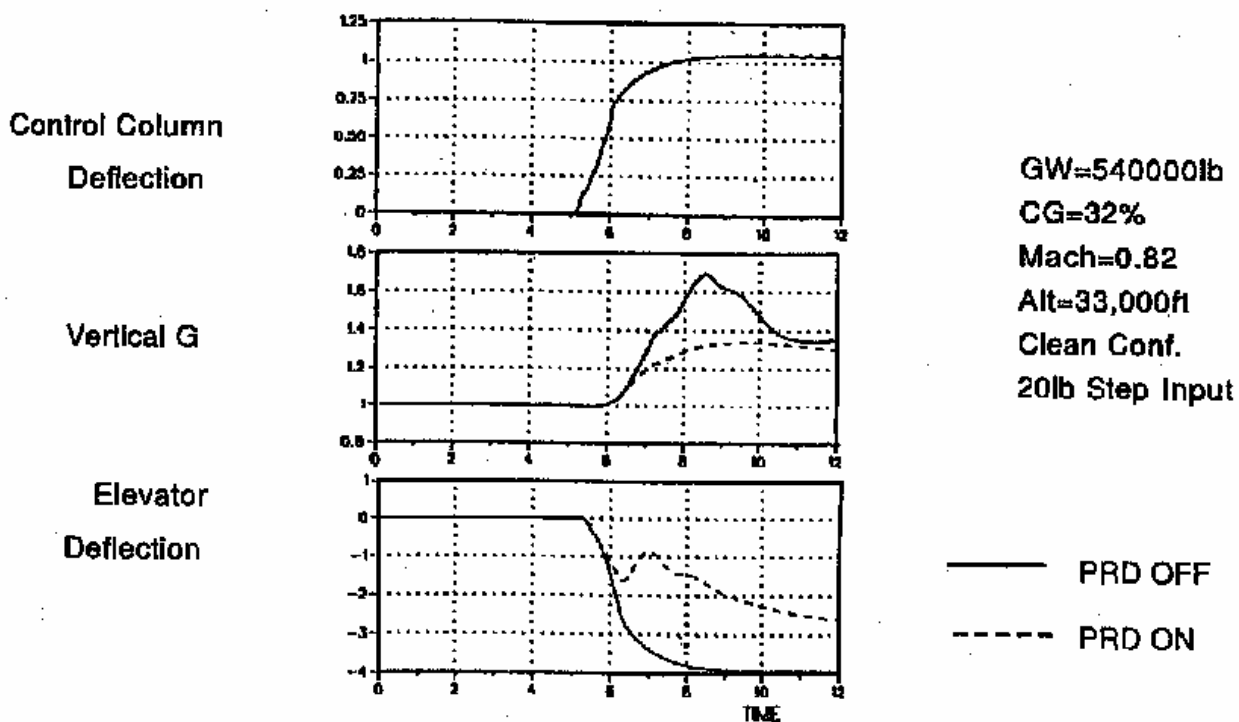
Fig.2 Response to 20lb Stick Force Input

- 9) The Response of the Aircraft when the Autopilot is Manually Overridden by the Application of Force on the Control Column  
When 20 lbs of force was applied and maintained on the control column in the nose up direction during autopilot operation, there was no change to the aircraft attitude. The Autopilot did not disconnect after this condition was maintained for more than one minute. When 40 lbs of force was applied to the control column in three seconds, there was a momentary increase of  $1^{\circ}$  in pitch but it returned to its original value. The autopilot, again, did not disconnect after this condition was maintained for more than one minute.

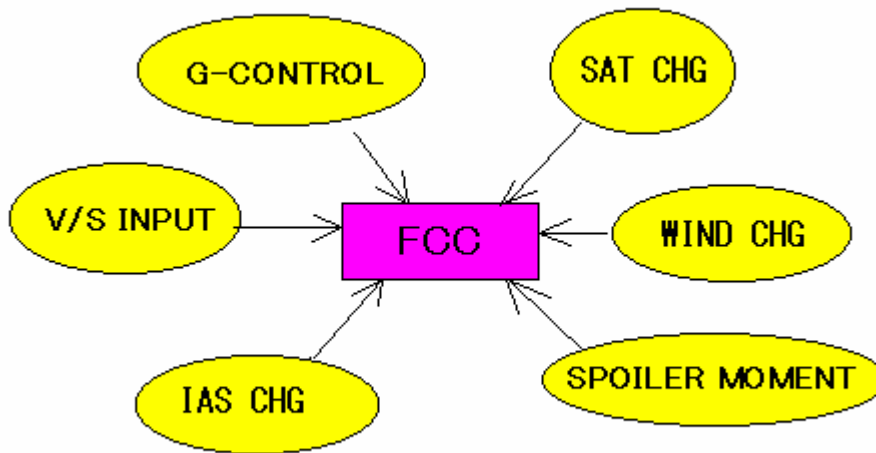
## Time until autopilot disconnection by force override

It was discovered that when the autopilot is disconnected by a overriding force on the control column, there was a possibility of both the Automatic Cut Off (ACO) and CRM functioning. As indicated in Attachment-5, a relatively rapid application of force results in a G limit exceedance disconnection occurring after 2 to 10 seconds. This leaves a “ACO” CFDS<sup>29</sup> fault record, while a gradual application of force of approximately 10 seconds that does not exceed the G limit will cause the CRM function to disengage the autopilot leaving a “E-CRM” CFDS fault record.

- 11) The CFDS Records when the Autopilot was Disconnected by an Overriding Force  
A study was made on disconnecting the autopilot by applying an overriding force. It was found that it was not possible to disconnect the autopilot within 2 seconds by applying an overriding force. The autopilot was completely able to maintain aircraft attitude if the force was 20 lbs and that it did not affect the flight at all. Twenty more experiments were conducted using more than 20 lbs of force to find out the relationship between the time to autopilot disconnection after the application of more than 20 lbs of force and the logic of that caused the autopilot disconnection. The 14 autopilot disconnections that took place between 2 to 13 seconds were ACO disengagements, a result of G exceedances. Six CRM autopilot disconnections were recorded for disconnection that took place 14 seconds or more after the application of force. (See Attachment-5)

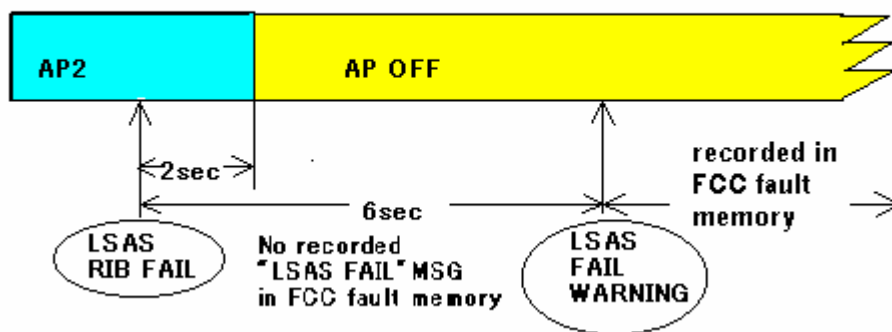
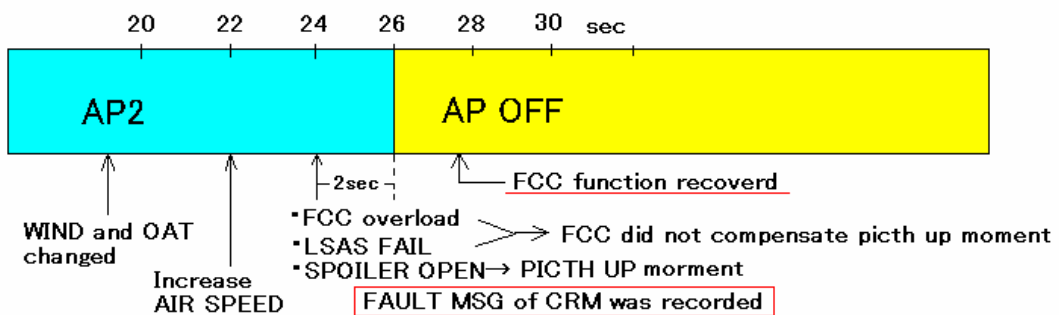
LSAS FAIL During Auto flight

A study on the MD-11 simulator was made on what would happen if a malfunction occurred in the FCC during autopilot use. A RIB LSAS failure, which simulates a RIB elevator hydraulic shutoff valve malfunction, was entered into the simulator while Autopilot-2 (FCC-2) was in use. After approximately 3 seconds, the autopilot disconnected, leaving the “ELEV ACT-RIB” and “EL CMD RESPONSE” fault messages in the CFDS. These are the same messages that were displayed on JL706. When these faults occur, the LSAS channel fail warning light will not illuminate for 6 seconds after the LSAS has failed and will not leave any CFDS recordings. However, after these 6 seconds, the overhead panel LSAS channel fail warning light will illuminate and simultaneously record a CFDS fault.

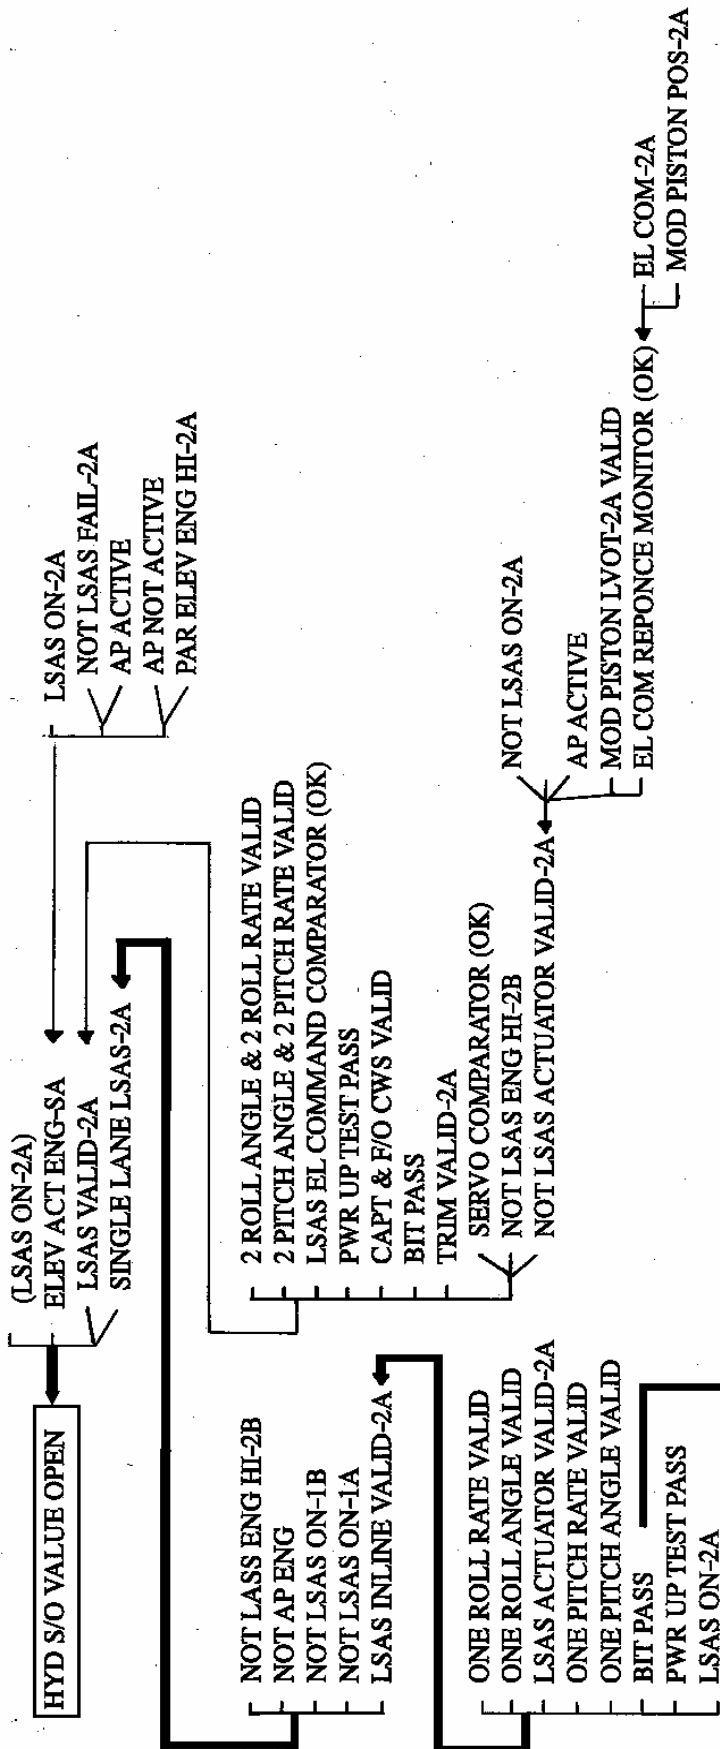
FCC continuous BIT function diagram

BIT function in FCC continuously monitors these items in this box. When the malfunction is detected, FCC cuts off electrical power supply to the hydraulic shut off valve in elevator PCU. Then the elevator gets unable to move as directed by FCC.
