The misconceptions of the accident investigation by Japanese Aircraft Accident Investigation Commission (AAIC) and the analysis by ALPA Japan.

Let's point out, the serious misconceptions involved in the Accident Investigation Report, from a technical viewpoint.

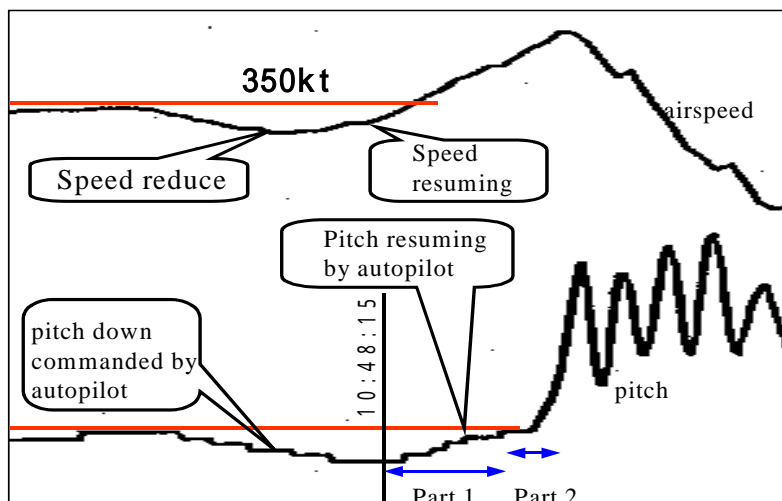
Fig-1

As shown in Fig.1 on the left, the pitch increase starts in the beginning with a slow rate (Part 1), followed by an abrupt one (Part 2).

This continuous pitch movement is reported as a result of the captain's intentional pulling of the control column. However ALPA Japan is assuming that the pitch increase of

part 1 and part 2 are caused by different factors. As for part1, at first a pitch decrease was commanded by the autopilot, ahead of the pitch increase command. There was an airspeed deceleration due to a wind change. The autopilot pitched down to accelerate to the commanded speed. As the airspeed returned to its commanded value, the autopilot gradually started to pitch back up.

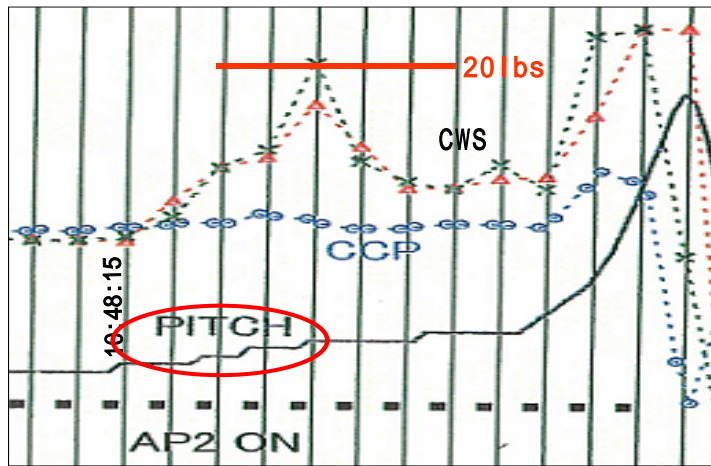
Fig-2

Fig. 2 on the left, which is the AAIC report, is showing only the right half of the graphic above (Fig.1). It only shows the part where the pitch already started upward, thus indicating an intentional pulling of the control column by the captain. In fact it was a pitch up commanded by the autopilot.

Moreover, recorded force, applied to the control column at that time, is lower than 20lbs. According to the McDonnell Douglas technical information, applying a force of less than 20lbs, will not cause the nose-up motion. So, it is obvious that the pulling of the control column, did not cause the nose-up motion.

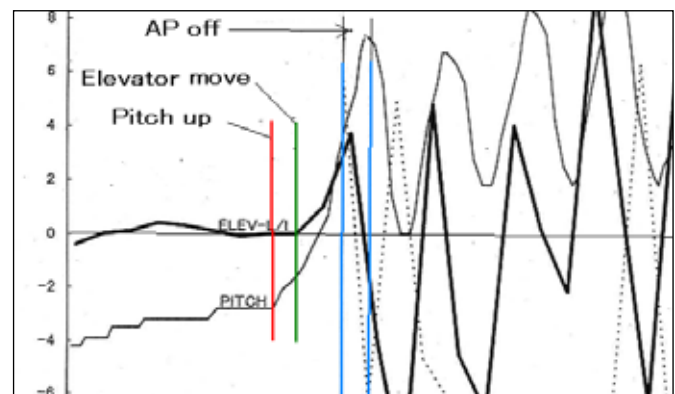
Fig-3

- Let's explain the part 2. On the pitch data record, extracted from the AAIC report, the abrupt nose-up motion began about three seconds before the autopilot was disconnected. Moreover the nose-up motion was started, before the elevator was moving. This indicates that the pilot's operation was not the cause for the nose-up motion.
- Now let's explain the reason for this abrupt nose-up motion.

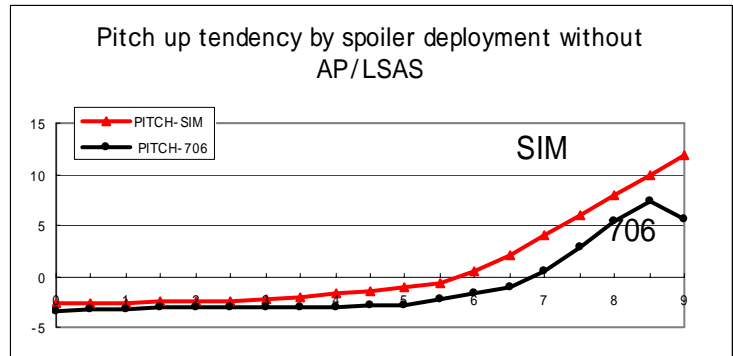
Fig-4

- By deploying the speed brake, a remarkable nose-up tendency will be promoted, which will be normally rectified not to do so, by the autopilot or the LSAS. If the autopilot or the LSAS malfunctioned, how much nose-up motion will occur by deploying the speed brake.
- For this experiment, ALPA Japan used the simulator. As a result of the experiment, almost the same pitch up movement as on the JL706 was confirmed when speed brake was deployed with no autopilot nor LSAS functioning.

Did the autopilot or the LSAS fail to function properly.

- In normal condition, the autopilot or the LSAS will cope with the nose-up motion and stabilize the aircraft, even if the speed brake is deployed. The FCC is always using the atmospheric data in which the aircraft is surrounded, to calculate and determine the commands for aircraft stabilization.
- However, if there is a rapid change of the surrounded atmospheric condition, the calculation cannot be completed timely due to saturation of CPU, thus causing an intermittent malfunction of the computer. This is the same situation as <freezing>, if we make many things do at once with our personal computer. The CPU (central processing unit) of the FCC used in MD-11, is about 20 years older than the CPU in our present personal computers.

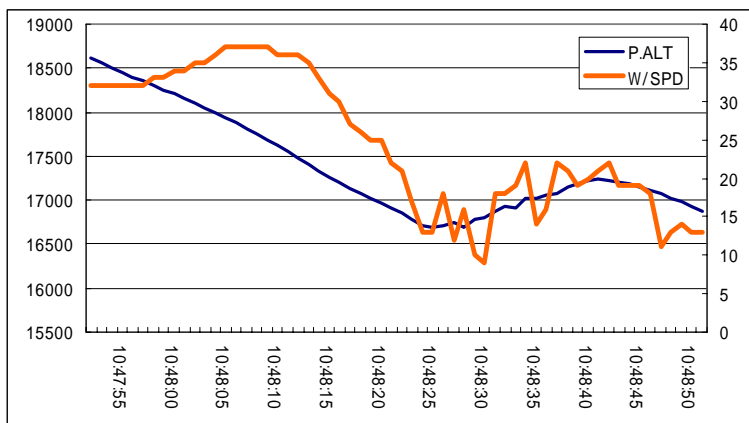
Fig-5

atmospheric data indicates a strong inversion layer. However the AAIC does not take this fact into consideration. Inversion layers exist, where rapid temperature change is observed, and it is known to easily generate disturbed airflow.

- McDonnell Douglas admits that there was a rapid change of airflow exceeding the limit designed for the autopilot. It is beyond understanding, why the AAIC does not take this into consideration, even if the manufacture company of the airplane, admits the rapid airflow change, exceeding the designed limit.
- How turbulent was the air ,surrounding the aircraft. As one of the examples, Fig.5 indicates the change of the wind speeds at the time of the accident.

The orange line shows that the wind speed has repeated increase and decrease violently. Such changes indicate the existence of a vortex in that specific area, and it also indicates an overloaded situation for the computer calculation.

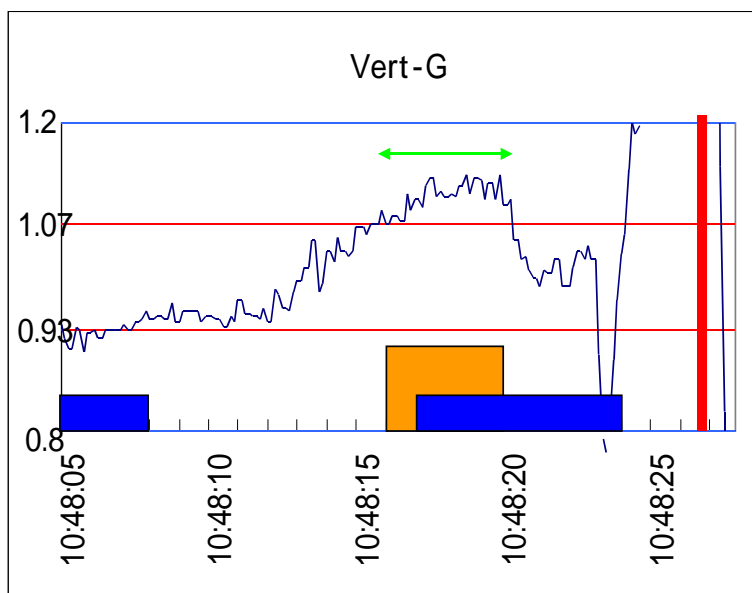
Fig-6

Fig.6 on the left shows the duration that G-force loaded on the aircraft and the deflection of the elevator were out of limit. The G-force, shown with the rugged line, is out of the limitation shown with the two red lines, where indicated by the green arrow. The time zone shown with the blue belt is showing when the horizontal stabilizer was out of the suitable position. The time zone with the brown belt is showing when the autopilot did not react, in spite of the captain's command.

- Taking all these things into consideration, it can be assumed that the FCC, which commands the autopilot and LSAS, was overloaded due to the turbulent airflow surrounding the airplane, and stopped functioning temporarily. Subsequently, an abrupt nose-up motion began by deploying the speed brake at the same time. About the continuing pitch oscillation will be explained later.

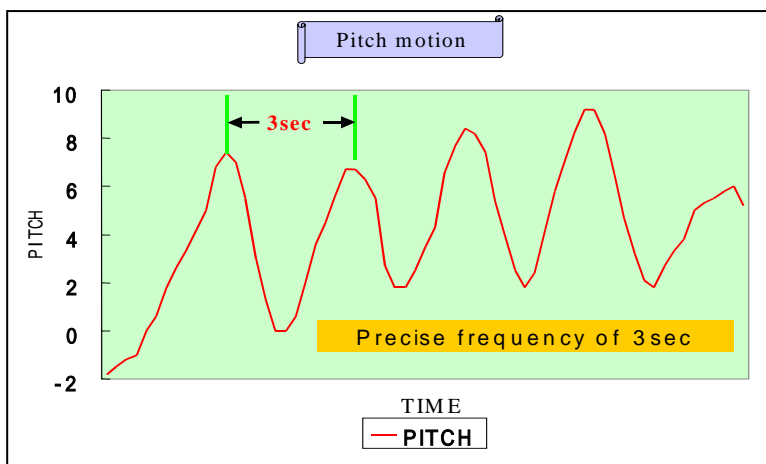
Fig-7

- As it is shown in Fig.7, the repeated up-and-down motion at the time of the accident has a short cycle of about 3 seconds. Moreover, it has a wide up-and-down amplitude of 8deg (a cockpit up-and-down motion of 5-7m), and was repeated with a **very accurate frequency** for 5 times.

* The up-and-down motion is impossible to reproduce artificially.

- To create an up-and-down motion artificially by pushing and pulling the control column, was experimented using the simulator. However, it was unable to reproduce such repeating pitching motion. As explained previously, the PRD, which was installed to stabilize the pitching motion, stopped the pitching motion immediately.

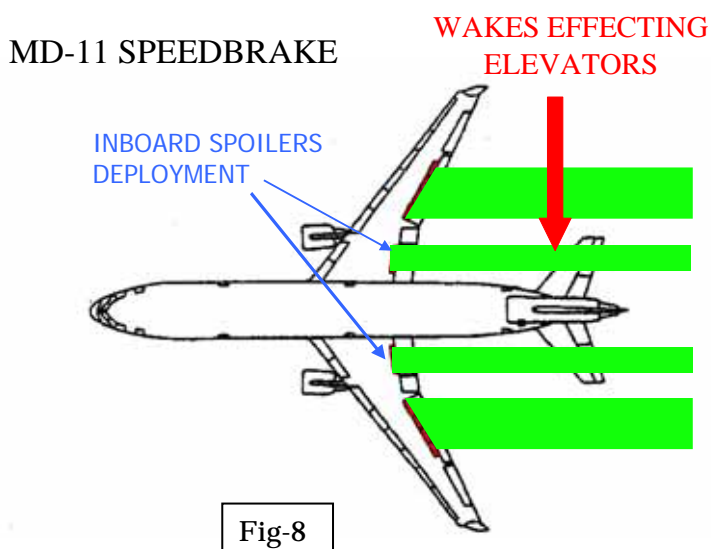
- There are several speed brake panels installed on the main wing (Fig8). Unlike other types of aircraft, all the speed brakes panels of the MD11 type aircraft, are fully deployed including the inner brakes (most close to the fuselage) during flight.

- Wakes from these inboard speed brakes, specific to the MD11, is usually designed not to affect the flight. However, as for the JL706 affected by the vertical vortex in the inversion layer, there is possibility that the wake from the spoilers did adversely affect the horizontal tail.

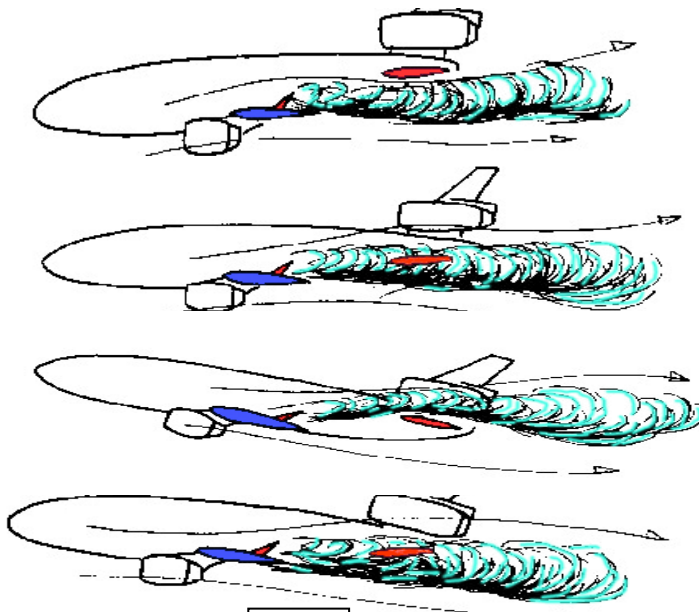
Fig-9

1 FCC malfunction occurred, due to strong inversion layer involving remarkable wind change.

2 Pitch-up motion was started by deploying the speed brakes for airspeed reduction.

3 Disturbance of the air current passing through the speed brakes affected the horizontal tail and significantly reduced the efficiency of the elevators. Consequently, the elevators were unable to inhibit the nose-up tendency resulting from the use of the speed brake, thus leading to a sharp nose-up motion. At the same time, the BIT function detected a fault in the FCC and disconnected the autopilot.

4 When the elevators and the horizontal stabilizer are no longer affected by the wake that was caused by the use of the speed brakes, as a result of a relatively sharp nose-up motion, the elevators quickly recover and the nose-down motion begins...

5 However, when the nose is lowered, the elevators are affected by the wake again, and the nose-up motion begins again, thus being unable to

control the attitude.

6 After closing the speed brakes, the wake disappeared and the aircraft regained stability.
