IFALPA ADO Committee Meeting 出席報告 (2017.5.23-25 Montreal, Canada)

IFALPA AIRCRAFT DESIGN AND OPERATION (ADO) COMMITTEE MEETING
BOMBARDIER HQs, MONTREAL, 23-25 MAT 2017**AGENDA ITEM C.6** **MANUFACTURERS**
BOMBARDIER DHC8-Q400 INCIDENTSPREPARED BY ALPA JAPAN

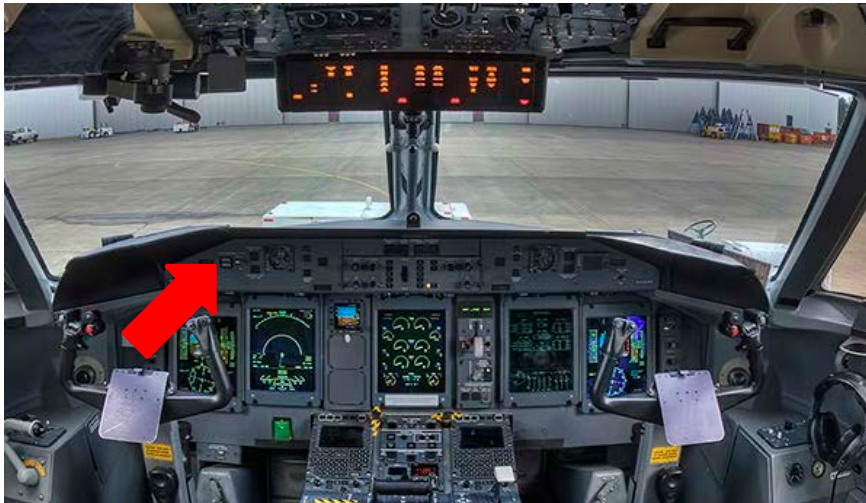
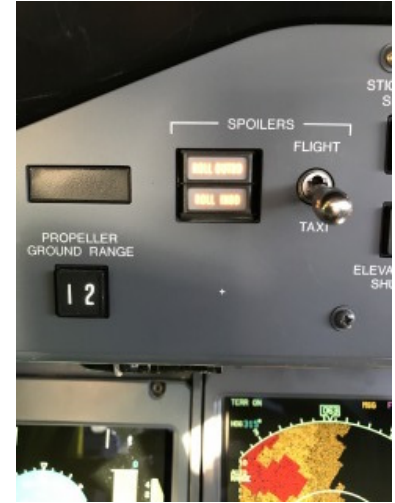
DHC8-Q400の通常操作手順では、PFは着陸後、速やかに「DISC」操作する（推力をゼロにして接地を確実にする、減速を確実にさせる）と共に、PMは「DISC」Lightが点灯することをモニターすることになっています。しかし、その「DISC」Lightが左席操縦席の正面に位置していることから、右席がPMの場合は接地直後におけるLightの確認が視覚的に困難となります。そのため、ALPA Japan ADO委員会はボンバルディア社に対して、以下のいずれかを実施することを提案しました。

DHC8-Q400 の操縦席と DISC Light の位置 (赤い矢印)

- ① 左席に着席するパイロットがPFの場合、左席操縦者は「DISC」Positionにセットした後、自らが「Light On」とコールする、または
- ② 「DISC」Lightの場所は両方のパイロットから視認できるように、Glareshieldの中心部分に移設すべきである。そうすることで、いずれかのパイロット(PF)が接地後に「DISC」Positionにセットした時、もう一方のパイロット (PM) がLightを確実にモニターすることが出来る

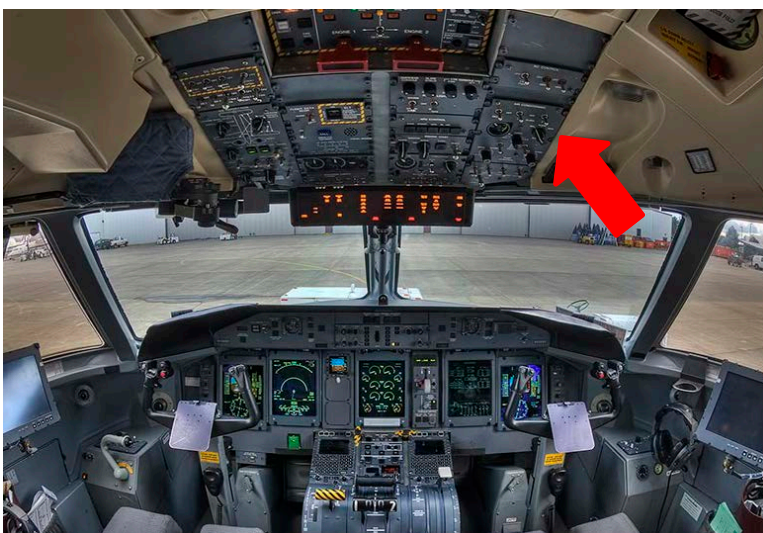
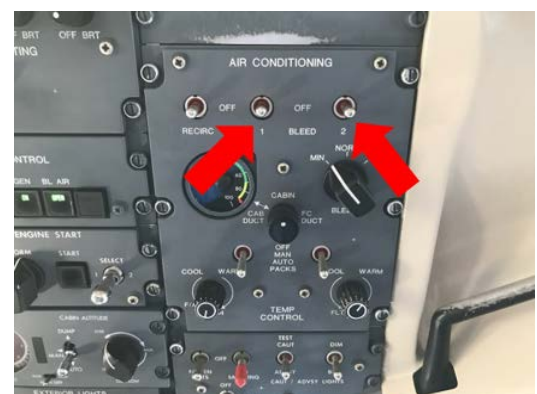
(2) **Bleed Switch** の形状及び緊急状態に至る前でパイロットに注意喚起するシステムについて
 日本で DHC8-Q400 型機を運航している ANAWINGS 及び日本エアコミューターでは、過去に Bleed Switch を OFF Position のまま上昇を続けていった結果、Warning System が作動したケースが散見されています。これは、通常操作では複数回に亘って Switch Position を確認する手順になっているものの、Bleed Switch の場所及び形状に起因したパイロットの見落としが根本的な原因と思われます。そこで、ALPA Japan ADO 委員会は以下の対策を実施することを提案します。

DHC8-Q400 の操縦席と Bleed Switch の位置 (赤い矢印)

- ① Bleed Switch は運航に不可欠なものであるにも拘わらず、その Switch は小さく Switch の On/Off を容易に視認するのは困難である。そこで Switch の位置を明確に把握出来るよう、Switch を大きなサイズに変更するか、新デザインとすること
- ② 現在の客室高度監視システムにおける Warning / Caution System としては、客室高度が 9,800ft に到達した時に操縦席において Warning System が作動するのみである。そこで客室高度が 9,800ft へ到達する前に、付加的な Caution System (Message あるいは Light) を設置すること

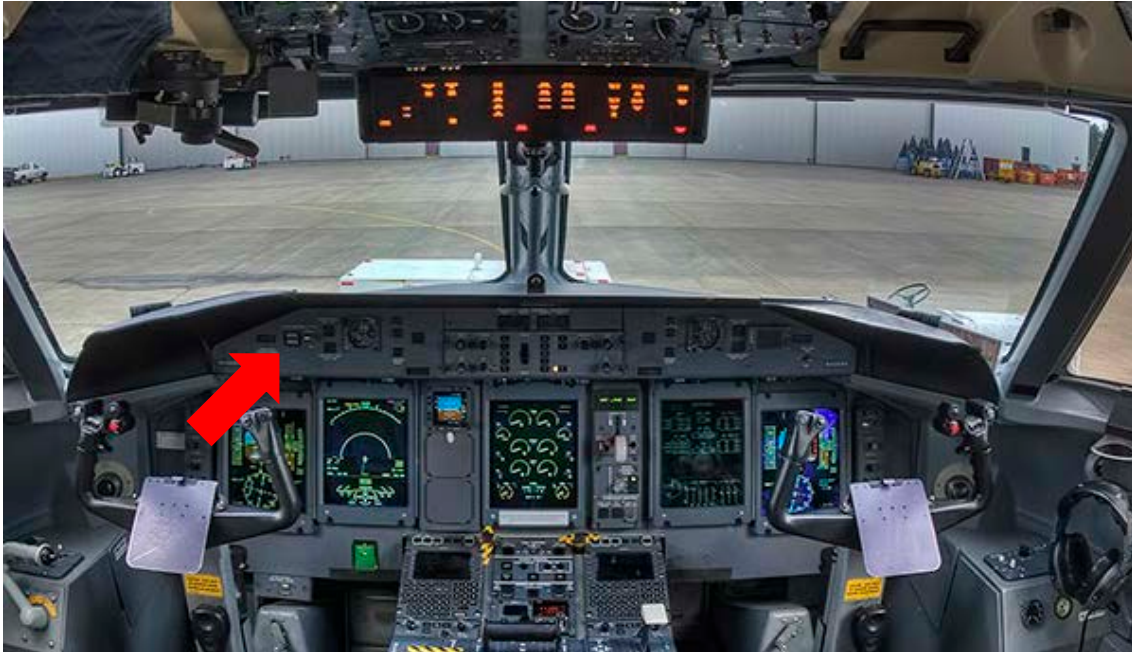
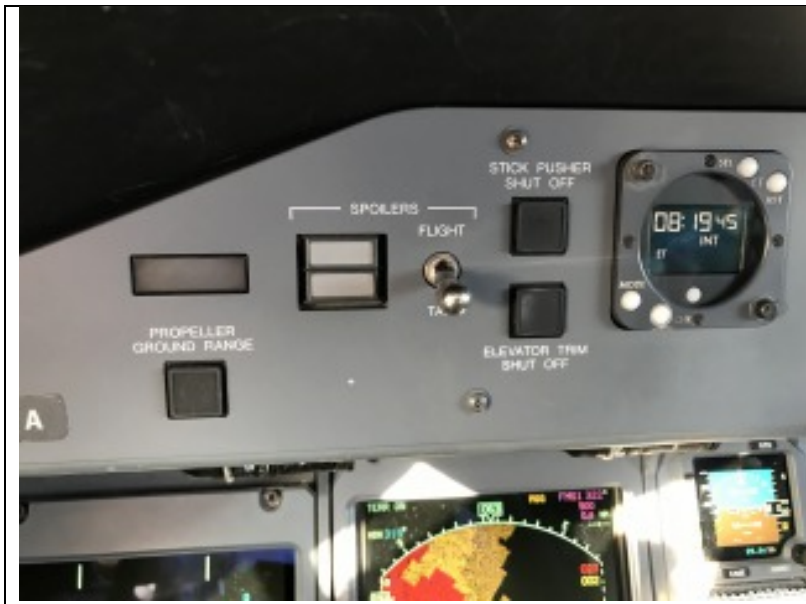
Figure 1: The cockpit of DHC8-Q400

Since the incident in January, two pilots have been grounded for four months by the order from Japan Civil Aviation Bureau, supposedly because pilots did not set the “DISC” position after landing, where the SOP states, “DISC position is useful to reduce the ground speed under slippery runway condition. Also the authority points out that PM (F/O) did not check the light on/off to confirm whether the “DISC” position was set after landing, as stated by the SOP. As a matter of fact, the right seat pilot has difficulty seeing the light on/off after landing, because the light is located on the glare shield in front of the left seat.

ALPA Japan ADO Committee has discussed this issue and concluded that either the current normal procedure where PM checks the light for the “DISC” on/off while landing roll should be revised, or the position of the “DISC” light be relocated, in terms of the cockpit “Design” and “Operation”.

The glare shield of the left seat

1. When PF is on the left seat, left seat pilot checks and calls “light on” after setting “DISC” position and PM/right seat pilot monitors. Or,
2. The position of the “DISC” light should be relocated to the center area of the glare shield which can be viewed by both pilots. Then, either one of the pilot/PF operates “DISC” while landing roll and another pilot/PM could monitor the light.

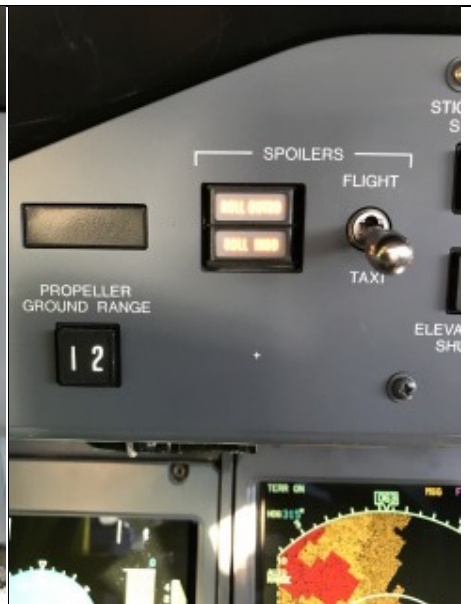
Figure 3:

At "DISC" position, both "ROLL OUTBD" and "ROLL INBD" lights illuminate.

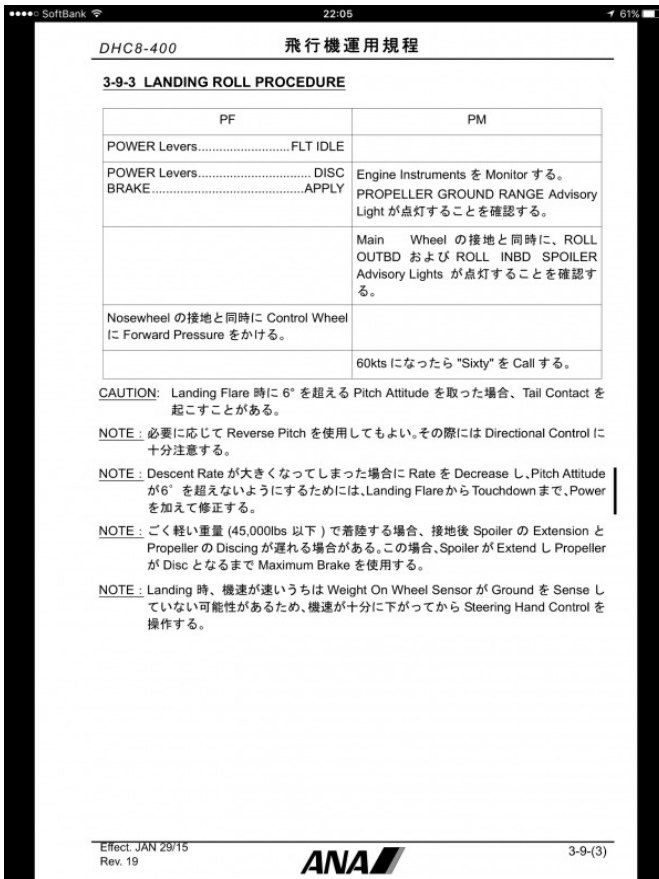
Figure 4:
Landing Roll Procedure

PF:
POWER Levers....FLT IDLE
POWER Levers..... DISC
BRAKE.....APPLY

PM: Monitor Engine
Instruments.
Check PROPLLER
GROUND RANGE Advisory Light.

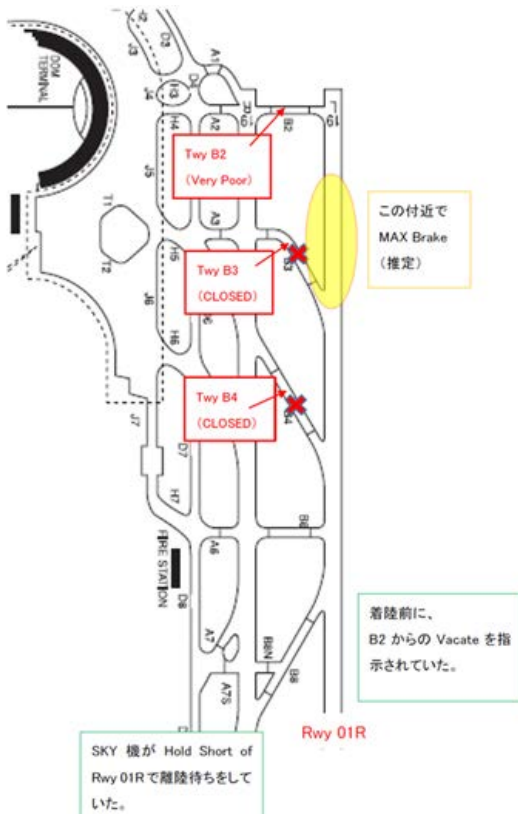
Figure 5: The runway 01R layout

On January 2017, ANA1831 operated by ANA subsidiary, ANAWINGS, departed Akita airport (RJSK) on Bombardier DHC8-Q400 made approach to runway 01R on ILS Approach to New Chitose Airport (RJCC), under snowy condition. Due to the closure of high-speed exit taxiways due to snow coverage, PF (PIC) planned to vacate from the taxiway at the very end of the 3000m long runway.

Followed by a stabilized approach, the plane made smooth landing at touch down zone of the runway. During the landing roll, PF did not set the thrust lever to the “DISC” position, similar to the thrust reverser on the jet planes. The reason was to keep certain ground speed on the ground in order to exit at the end of the runway. Upon approaching at the end of the runway, PF pressed on the brake but felt no deceleration, so pressed the brake harder. As the plane approached near the end of the runway, PF decided to taxi straight to the overrun area to avoid hitting some runway edge lights, and finally stopped in the overrun area. There was no injury, and no damage to both the airplane and the ground equipment. This accident is under investigation by Investigation by Japan Transportation and Safety Bureau.

- ←The exit taxiway
- ←PF applied MAX Brake.
- ←Closed Hi SPD Exit TWY
- ←Closed Hi SPD Exit TWY

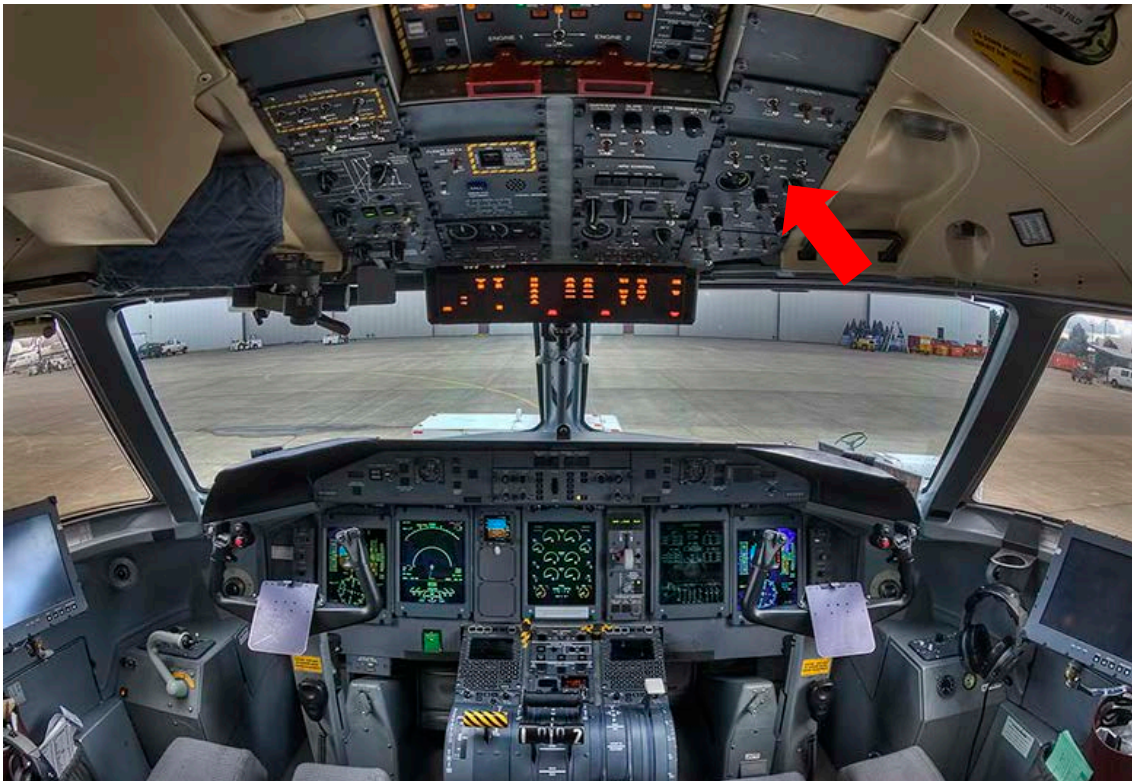
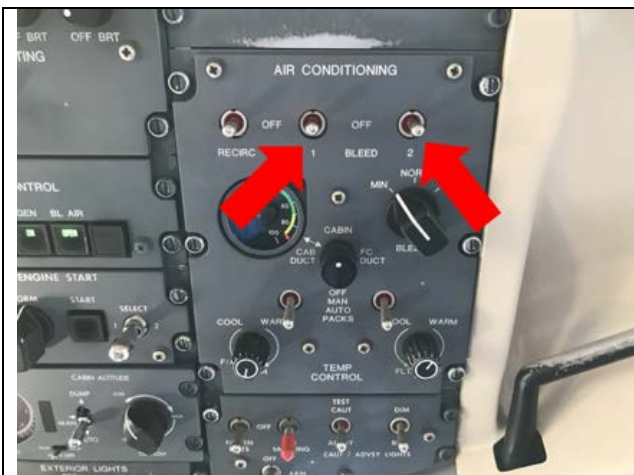
Another ANAWINGS flight, Bombardier DHC8-Q400 departed Chubu International Airport (RJGG) on the night of March 2017. PM (COP) had missed setting the bleed switches "on" while after start procedure, and also did not check the switch position during the taxi-out procedure. Upon taxi & takeoff checklist, the SOP of the DHC-Q400 in ANAWINGS states that PM should physically touch the bleed switches and confirm its' position because toggle-type bleed switches are tiny and sometimes difficult to recognize their switch position at a glance, especially during night. PM, again, did not follow this procedure.

After airborne, the captain transferred to PM and one reason, switch being located slightly far from his left seat, and other being dark cockpit, upon after takeoff checklist he did not notice the switch position "on".

When the plane climbed passing around FL170, "Cabin Pressure" warning lit, so they quickly requested descent to 10,000ft. During the descent, crew checked "Cabin Pressure" checklist in the QRH (Quick Reference Handbook) and found out that bleed switches were in off position. Consequently, they set the switches "on" and continued flying to their destination.

Figure 2:
Bleed SWs of DHC8-Q400

1. Nevertheless the bleed switches are inevitable for the flight operations, the switches are very small and difficult to identify, so these should be changed to larger size or adopt new design for clear identification.
2. Current warning/caution system for the cabin altitude monitoring system gives the warning in the cockpit when cabin altitude has reached 9,800ft. Additional caution system (e.g. message or light) should be adopted before cabin altitude reaches 9,800ft.

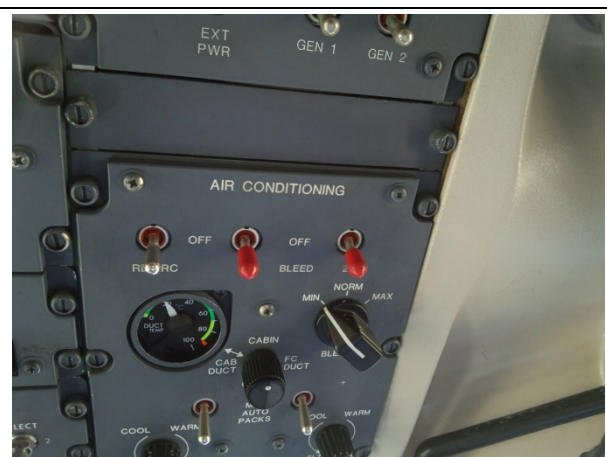
Figure 3:
SWs of other carrier
(Better, but not enough)
