# Japan Airlines 706 Accident Investigation Report

Japan Airlines McDonnell Douglas MD-11 JA8580

Over Shima Peninsula, Mie Prefecture, Japan

ALPA Japan Technical Support Team

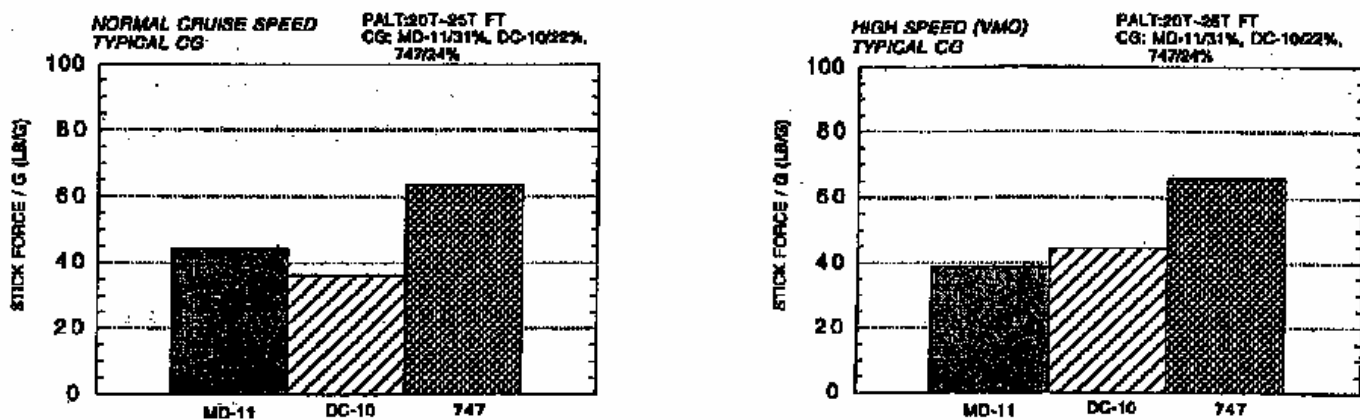
Fig.2 Response to 20lb Stick Force Input

These alterations in design made the MD-11 consume less fuel on the one hand but the small horizontal stabilizer and aft CG reduced the stability of the aircraft. At high altitude and high speed, the control feel to raise and lower the nose was very light and the same control input would result in a larger reaction in the MD-11 than other aircraft. According to McDonnell Douglas (see Attachment-4), at normal cruise speed, stick force per G required on the MD-11 was 44 lbs, in comparison it was 64 lbs on the B747. Similarly, at V<sub>mo</sub> it was 39 lbs on this aircraft while the B747 required 67 lbs. A function of the FCC<sup>16</sup>, LSAS<sup>17</sup>, was used to compensate for this sensitive reaction of the aircraft due to the light control feel of the control column. In other words, the FCC functioned as the autopilot and during manual flight, its LSAS function maintained the aircraft pitch attitude when control column pressures were below 2 lbs. Due to the accidents that had occurred because of abrupt pitch changes during manual flight reported since the MD-11 became operational, a refit was made to prevent large pitch changes. LSAS software was modified in 1996 and a pitch rate damper function that was continuously operational at and above 15,000 ft was added. (See Attachment-4, Fig 2)

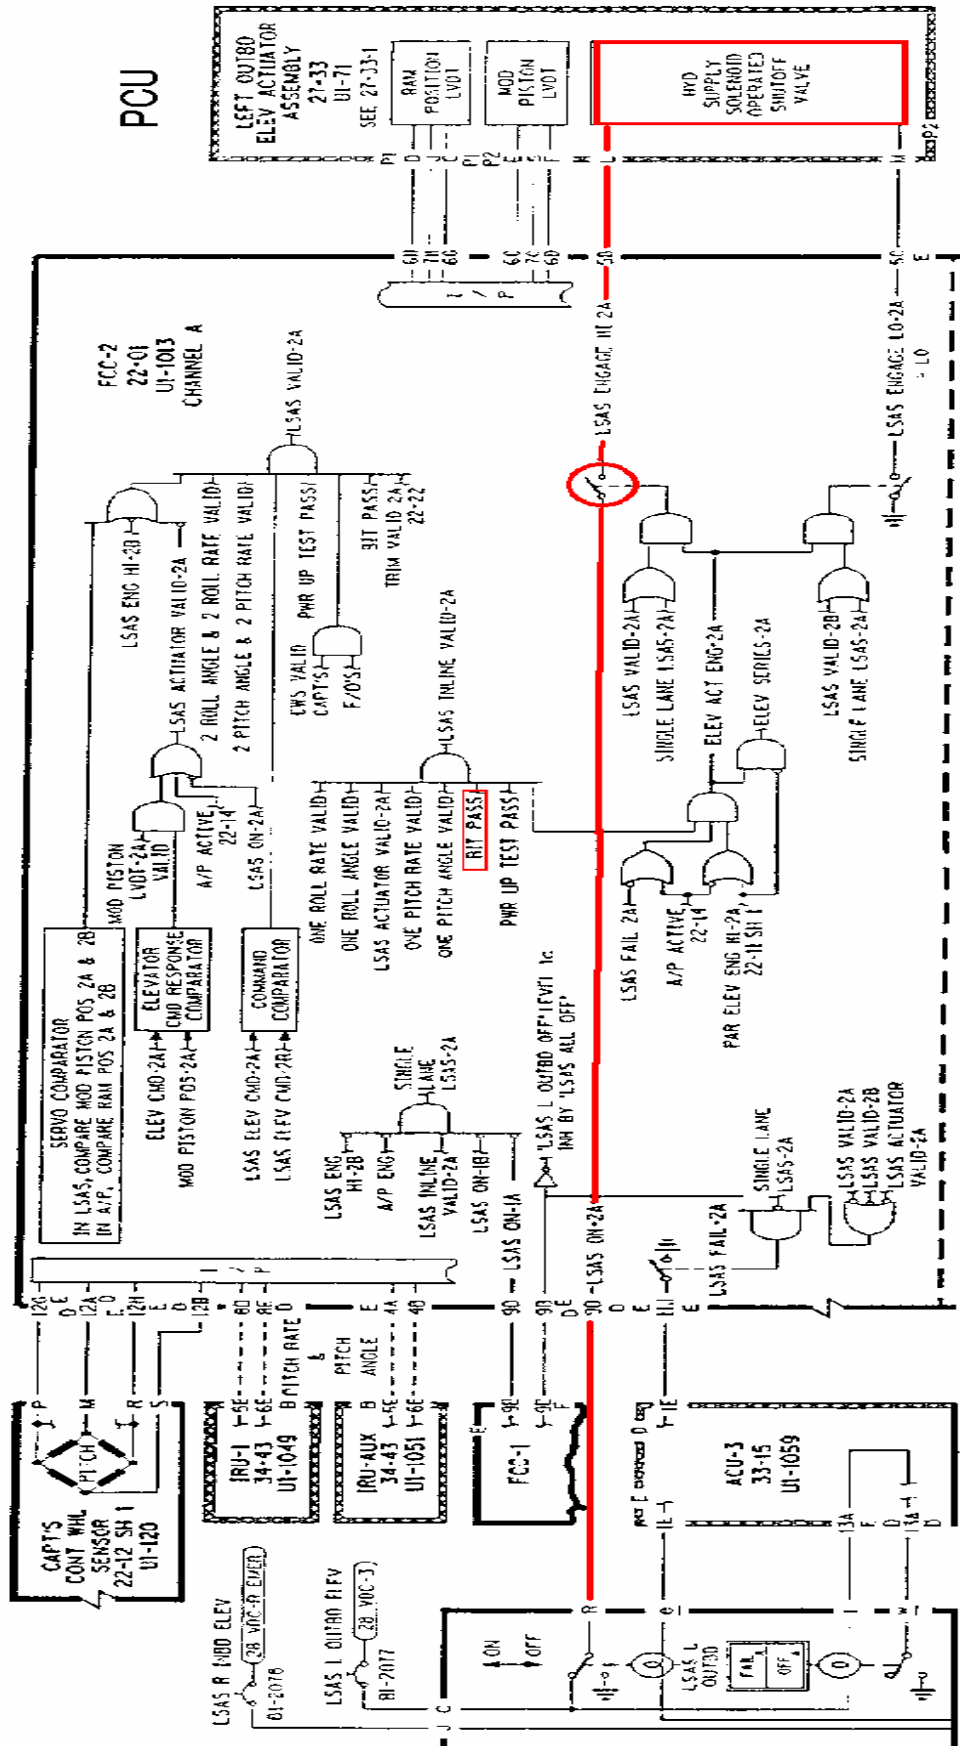
# FCC controls the hydraulic shut off valve in elevator PCU

This chart shows LOB elevator PCU, same as other elevator systems

BIT function in FCC continuously monitors these items in this box. When the malfunction is detected, FCC cuts off electrical power supply to the hydraulic shut off valve in elevator PCU. Then the elevator gets unable to move as directed by FCC.

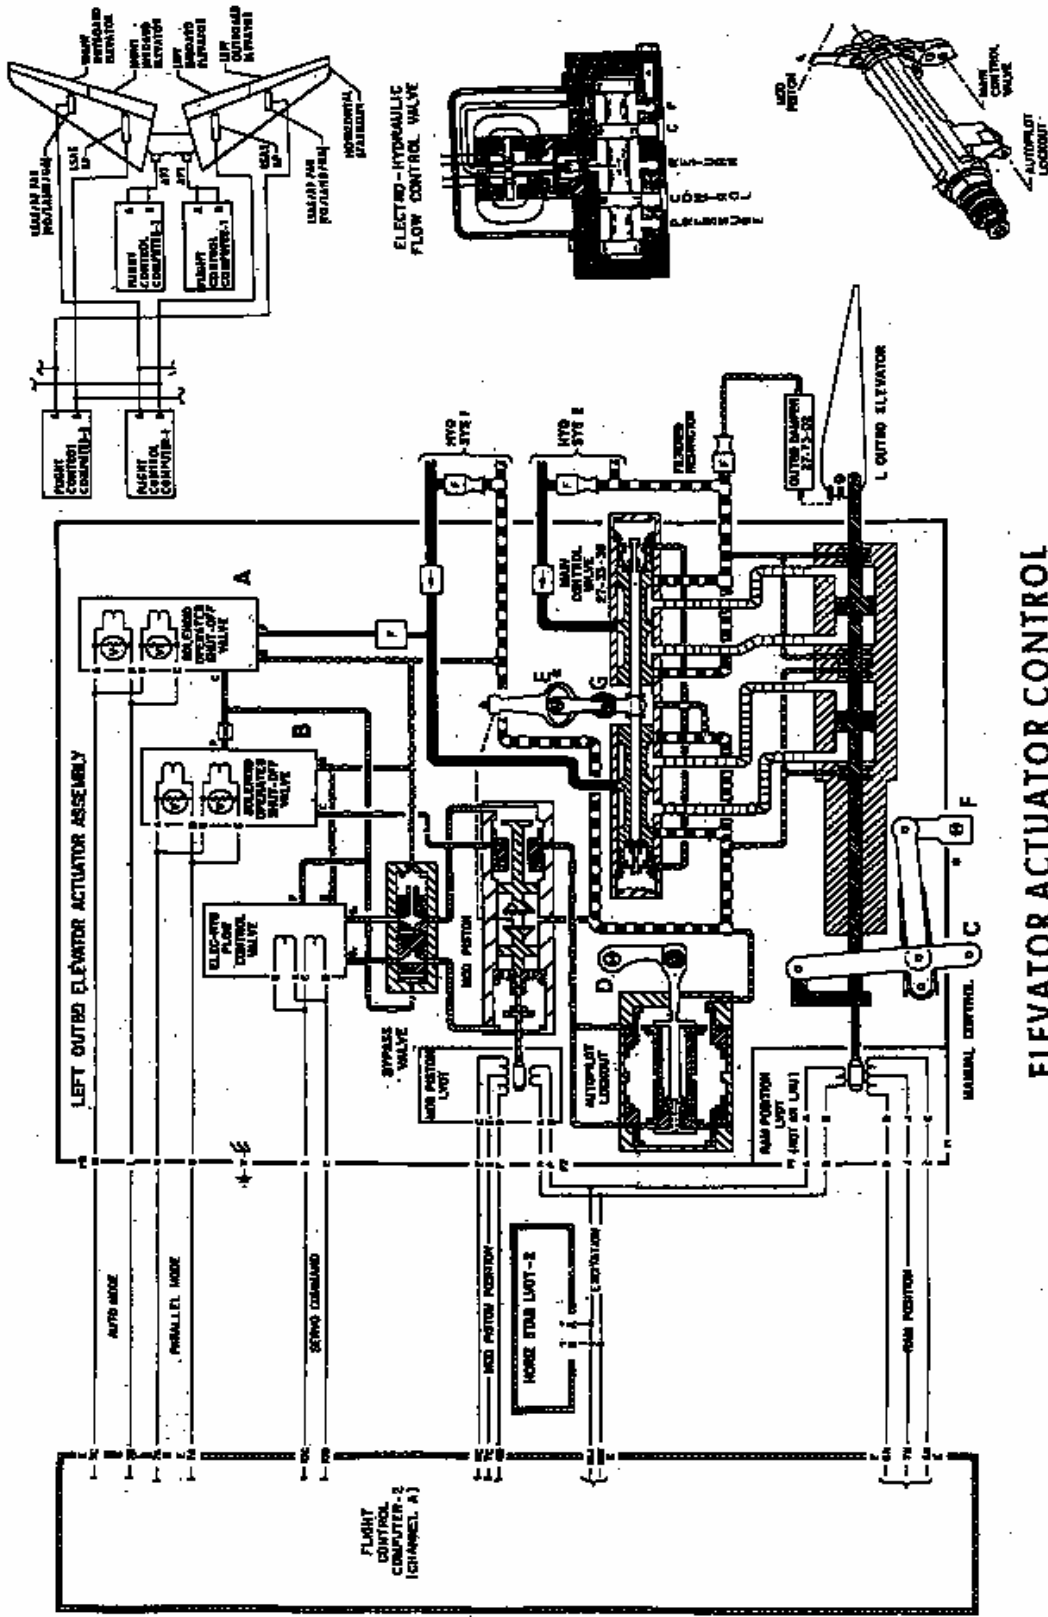
# Elevator PCU

This chart shows LOB elevator PCU, same as other elevators
